The Struthers-Wetmore-Schimmelfeng House Building Assessment and Preservation Plan

Warren County Historical Society

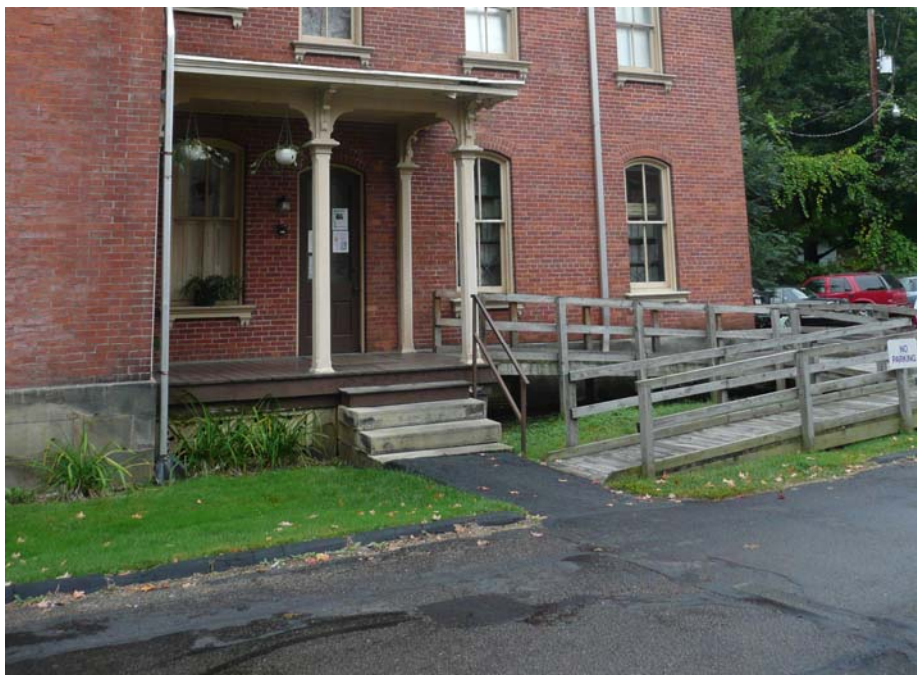
Asphalt Walkway to Side Entrance

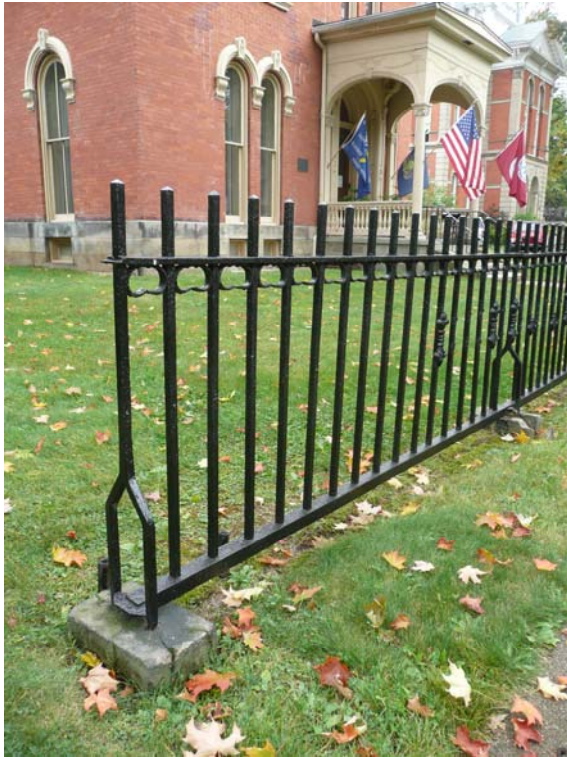
Fence along Front Property Line

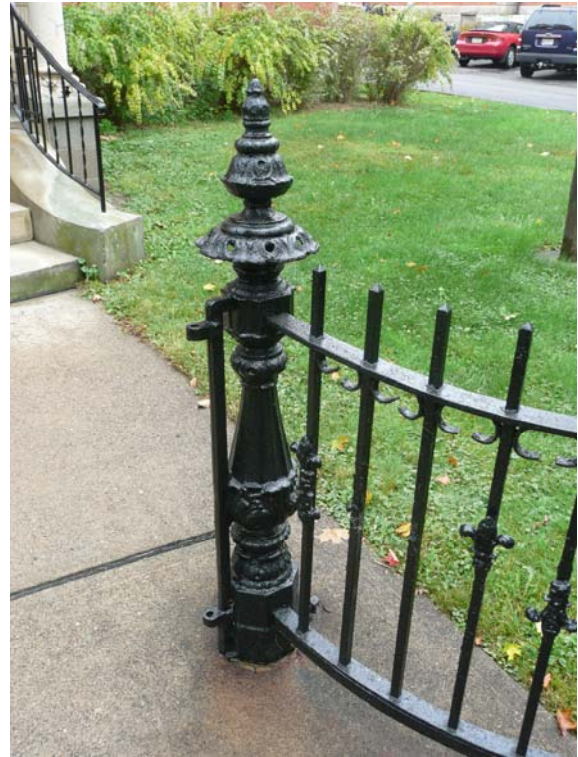
Detail of Fence at Entrance Walkway

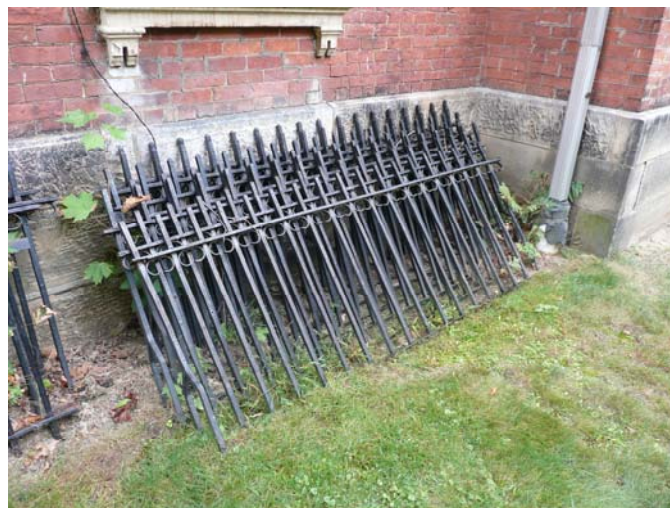
Extra Fence Sections along West Wall of House

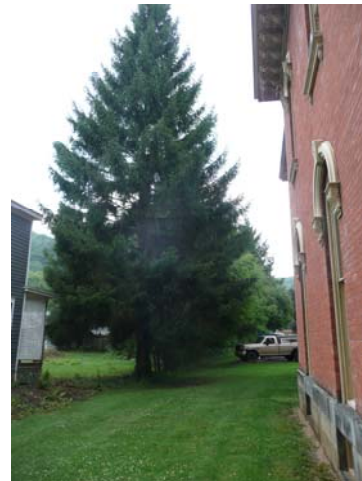
Trees along West Property Line

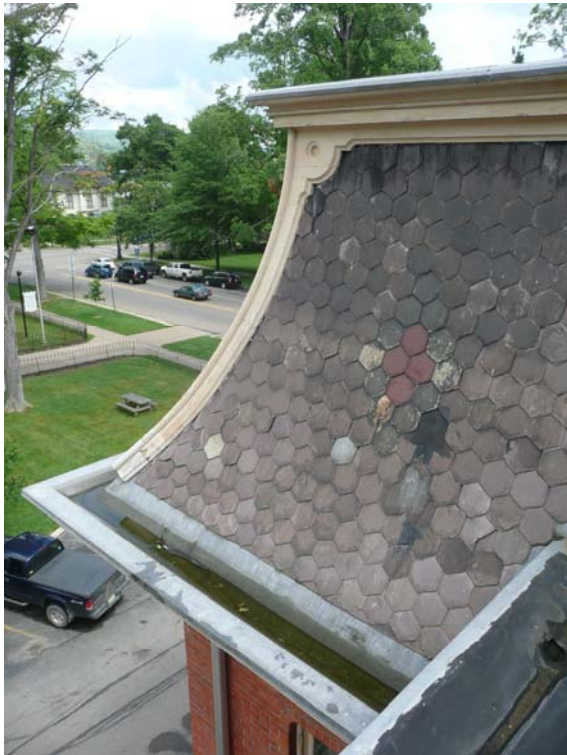
*View of North Side (East) of Front Mansard Roof
(Note standing water in gutter and
incorrect repair of missing slate)*

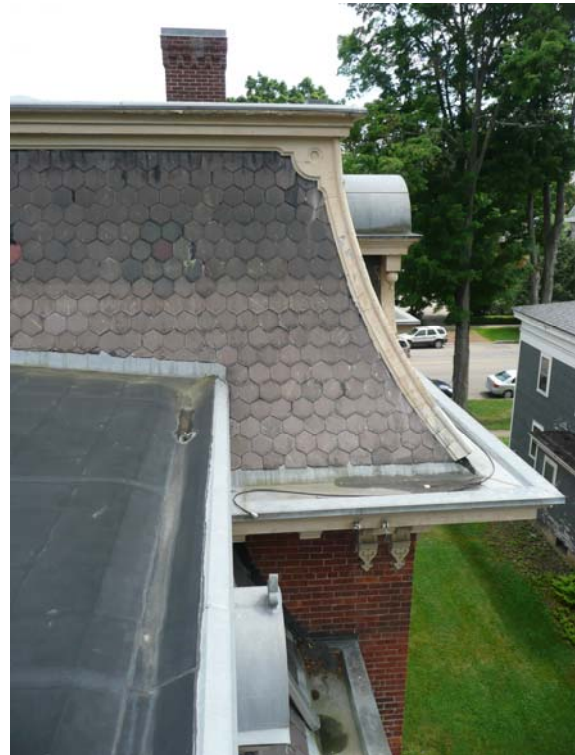
*View of North Side (West) of Front Mansard Roof
(Note heat tape in gutter)*

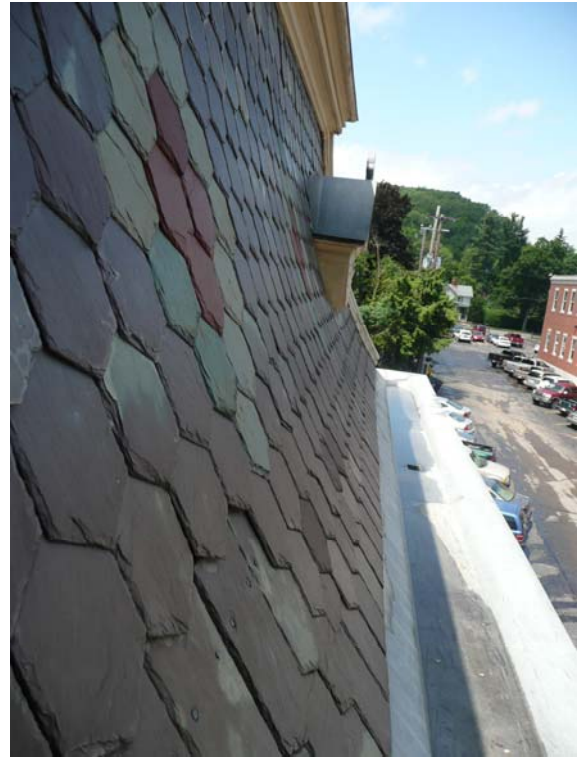
*Detail of Slate at Rear Roof
(Note several missing slate at bottom of photo)*

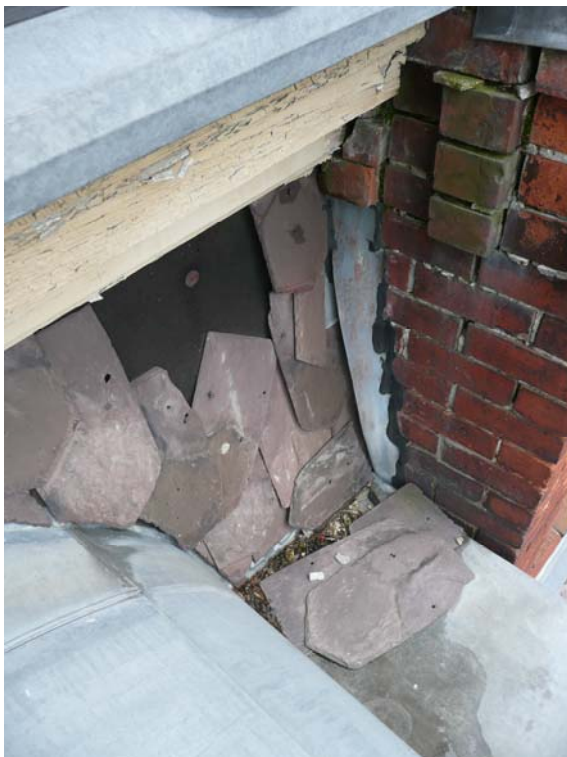
Damaged Slate North of West Chimney

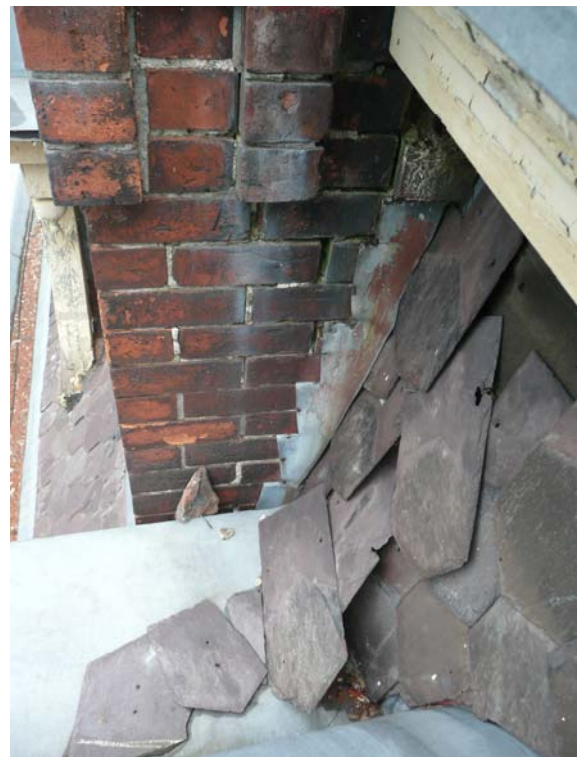
Damaged Slate South of West Chimney

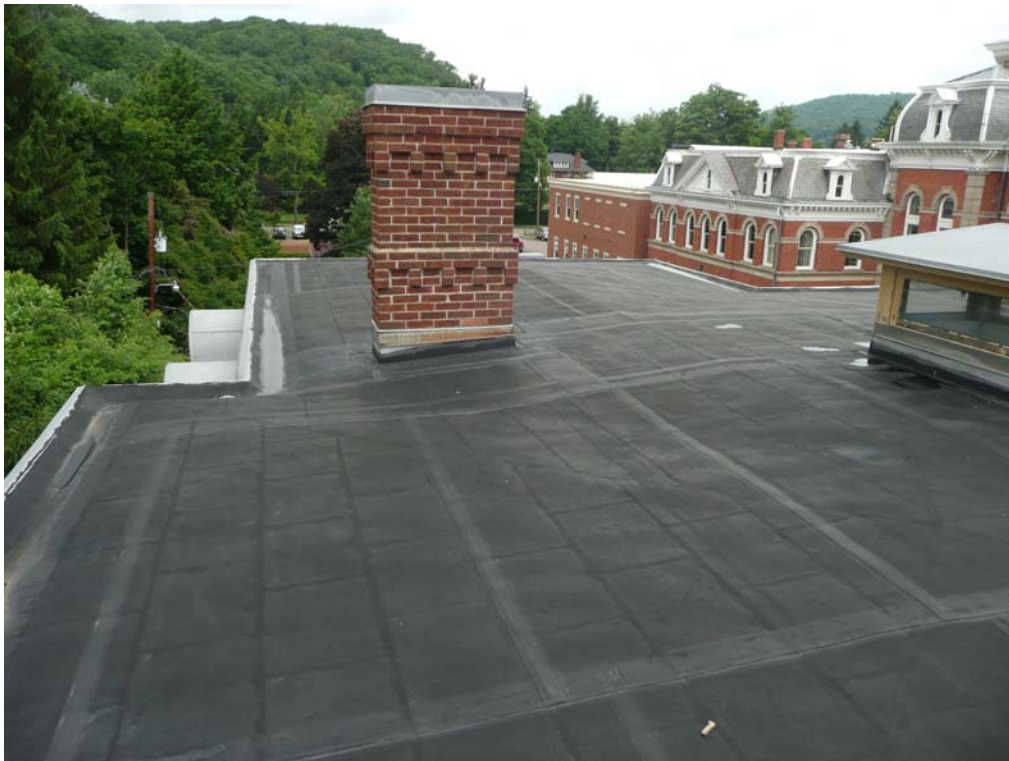
View Looking North from Southwest Corner of Front Roof

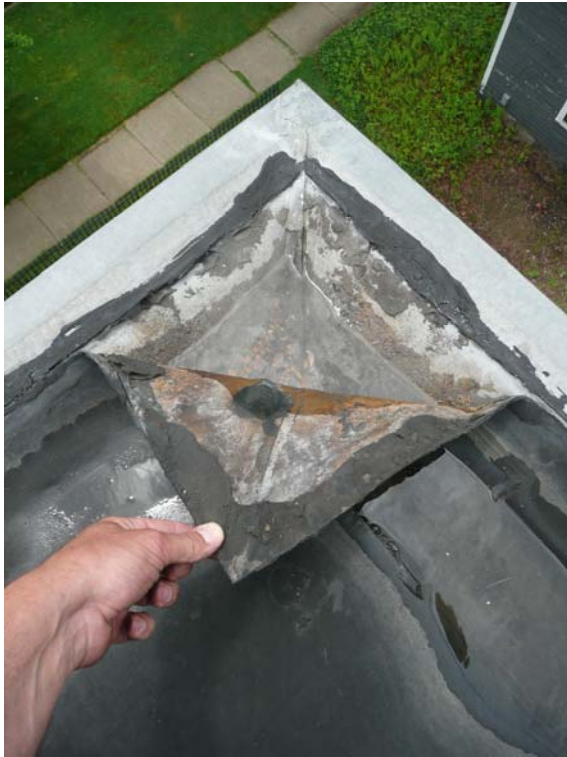
*Failed EPDM Roofing at Southwest
Corner of Front Roof*

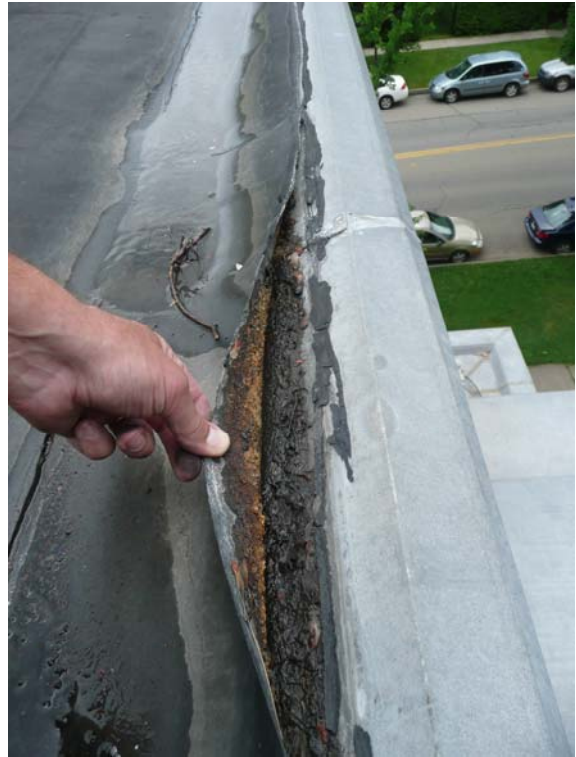
Failed EPDM Roofing at West Edge of Front Roof

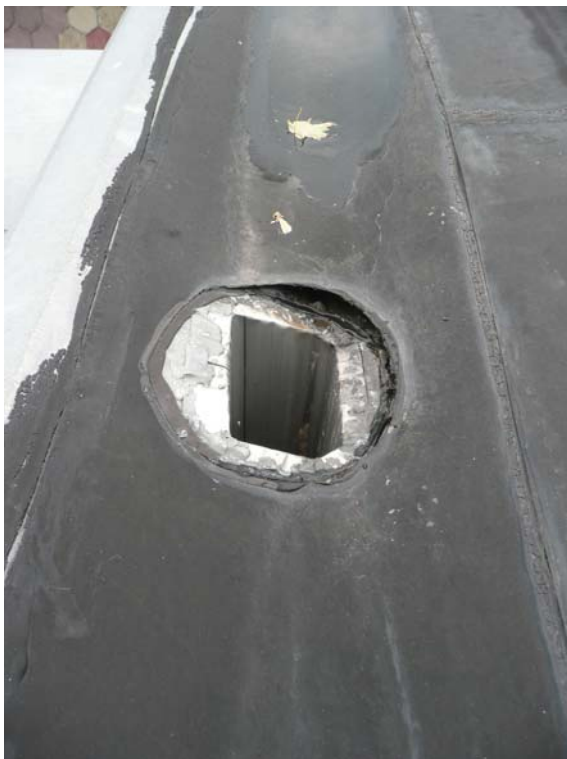
Failed EPDM Roofing at Downspout (Typical)

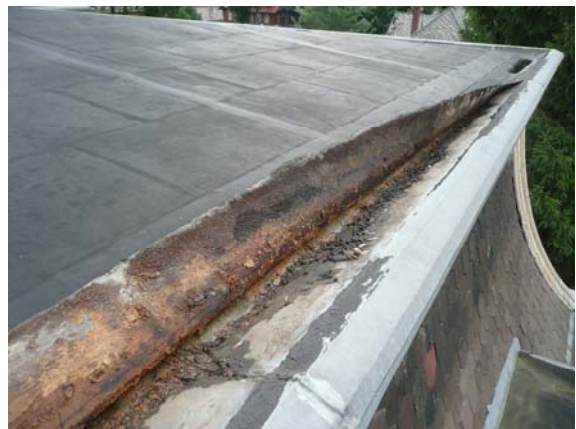
Failed EPDM Roofing at North Edge of Front Roof

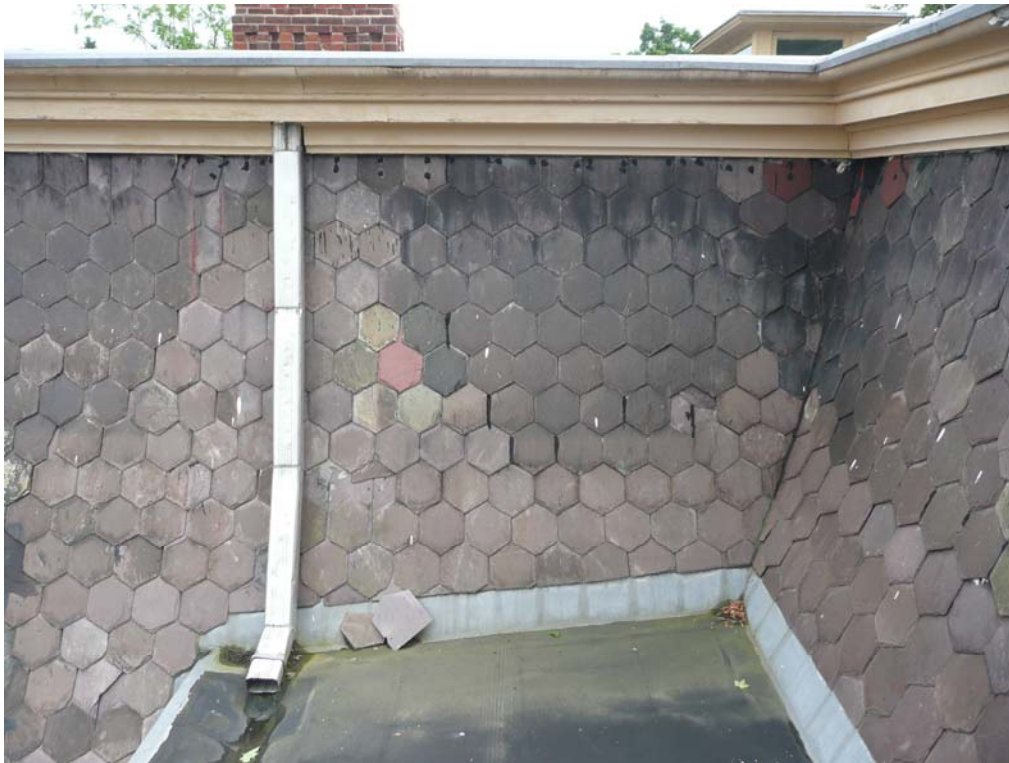
View of North Side (east) of Front Roof Showing Original Slate and Downspout from Flat Roof

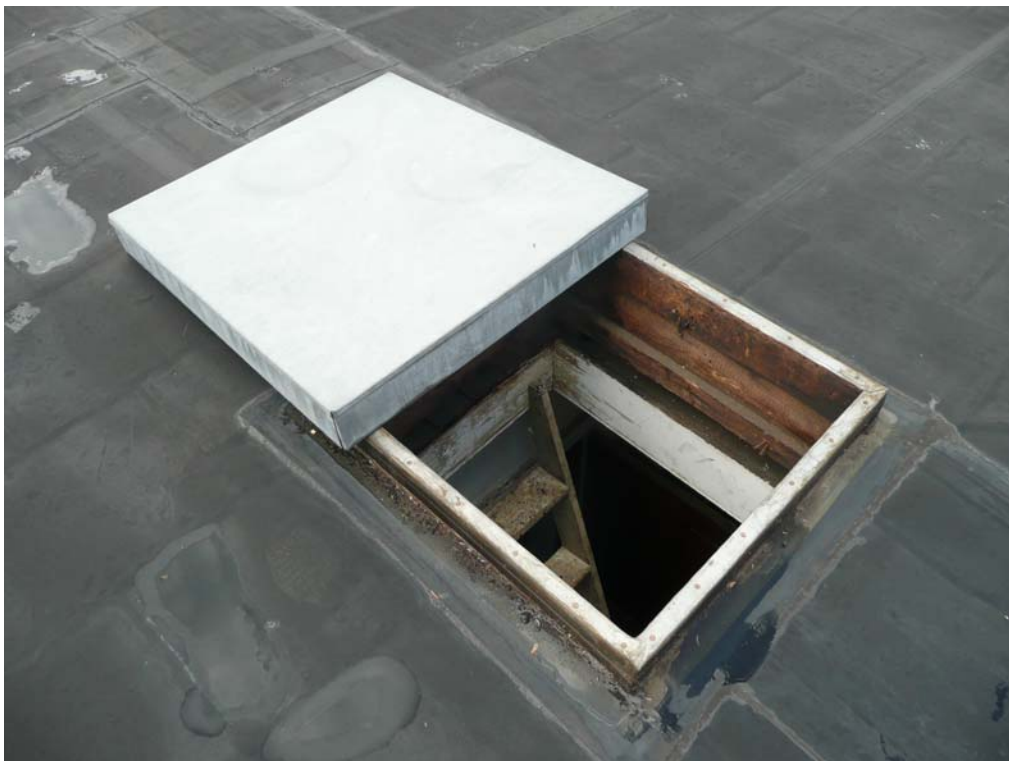
Roof Access Hatch at Front Roof

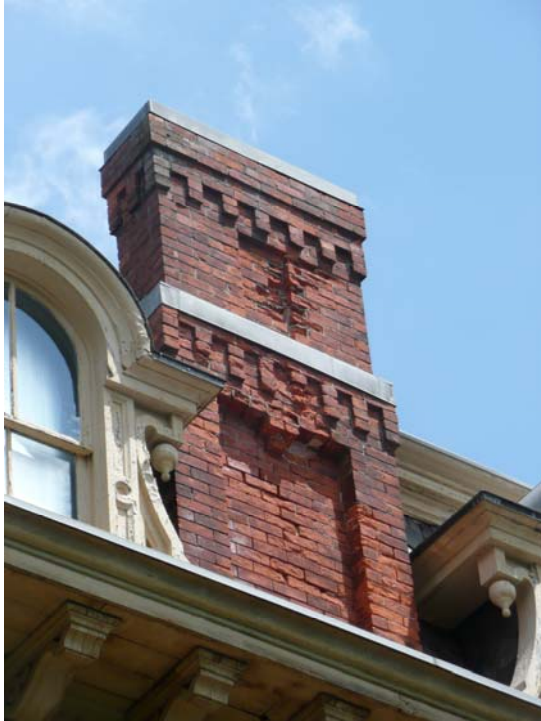
Chimney #1 – West Face

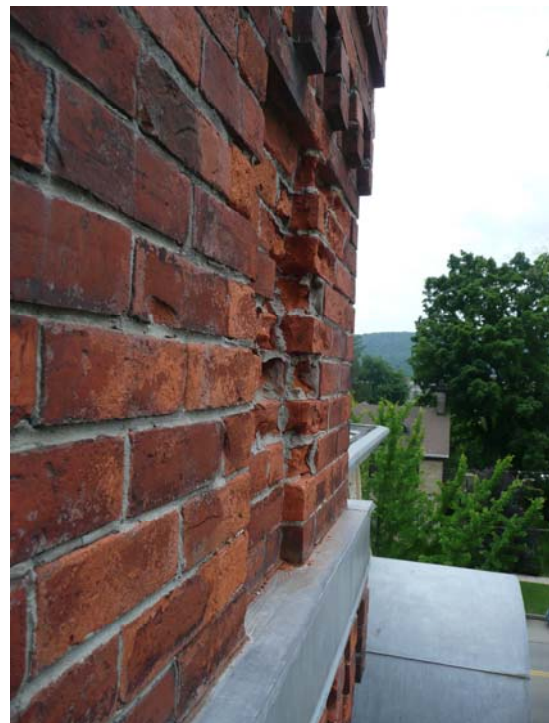
Chimney #1 – Detail of West Face

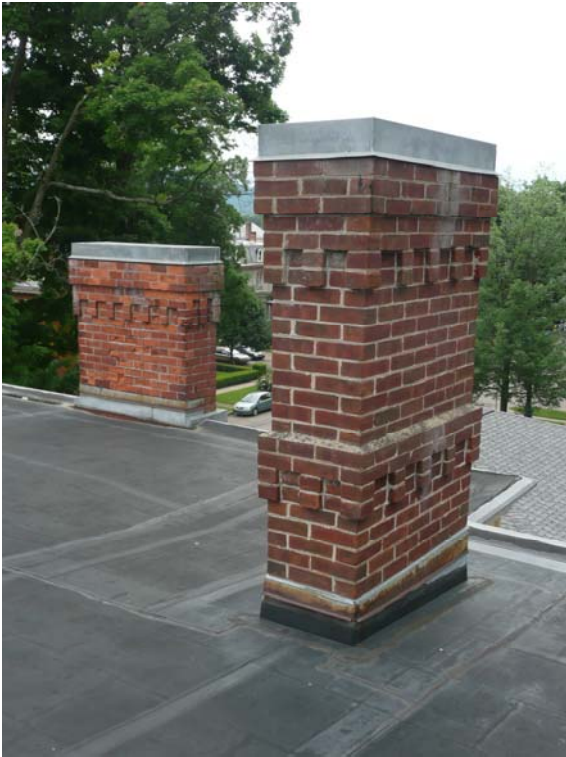
*Looking West at Chimney #2
(Chimney #1 in background)*

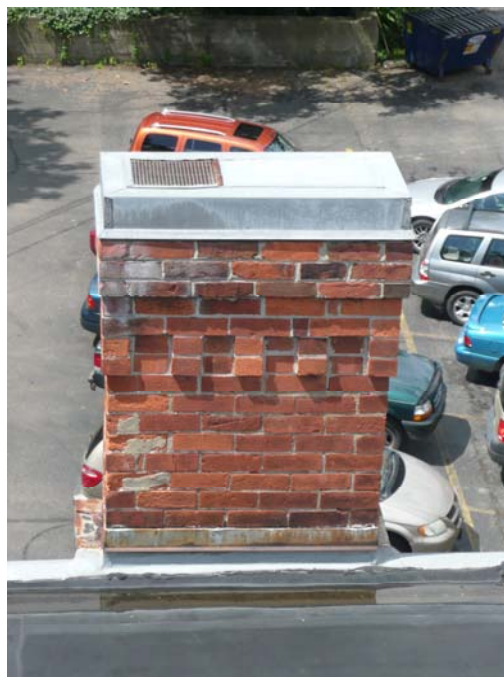
Looking North at Chimney #4

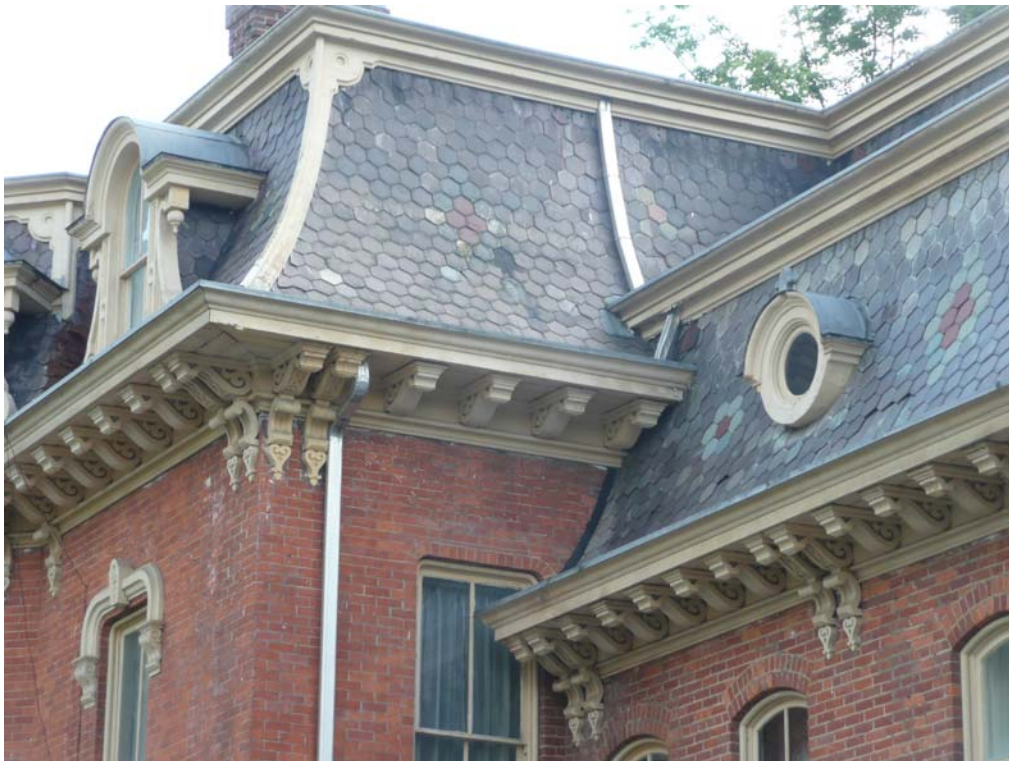
*Typical Upper and Lower Cornices at Mansard Roof
(Northeast corner of front mansard roof)*

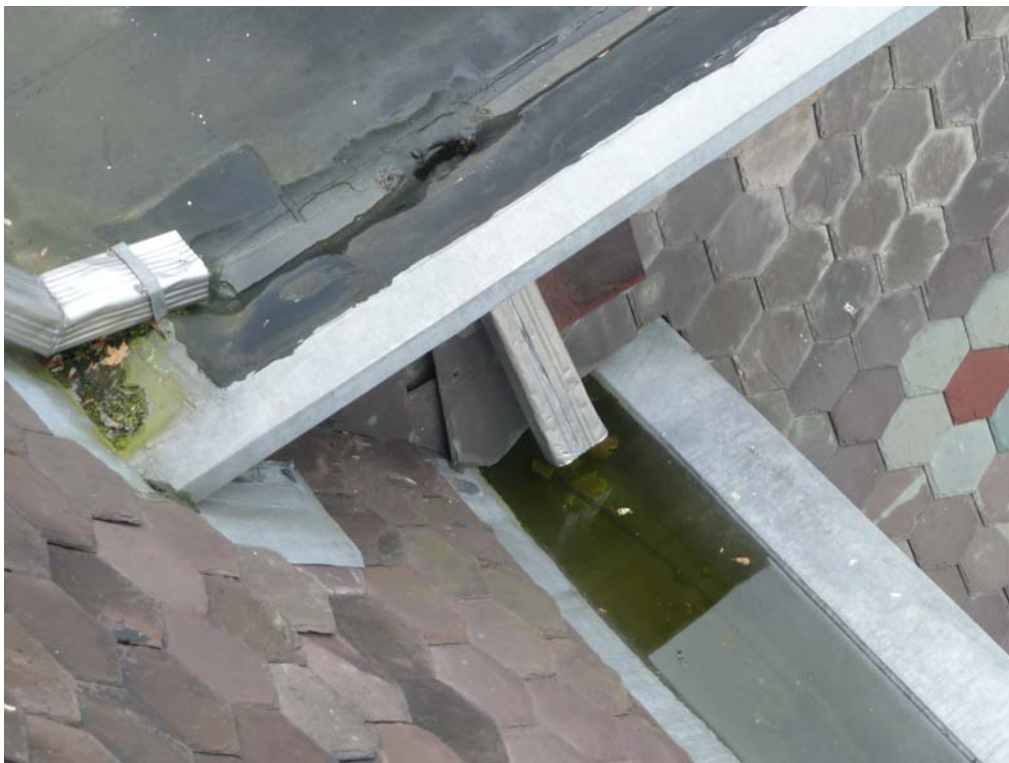
*Detail of Gutters at East Side Intersection of Front and Rear Roofs
(Note loose slates and standing water. This is the location of an active water leak inside building)*

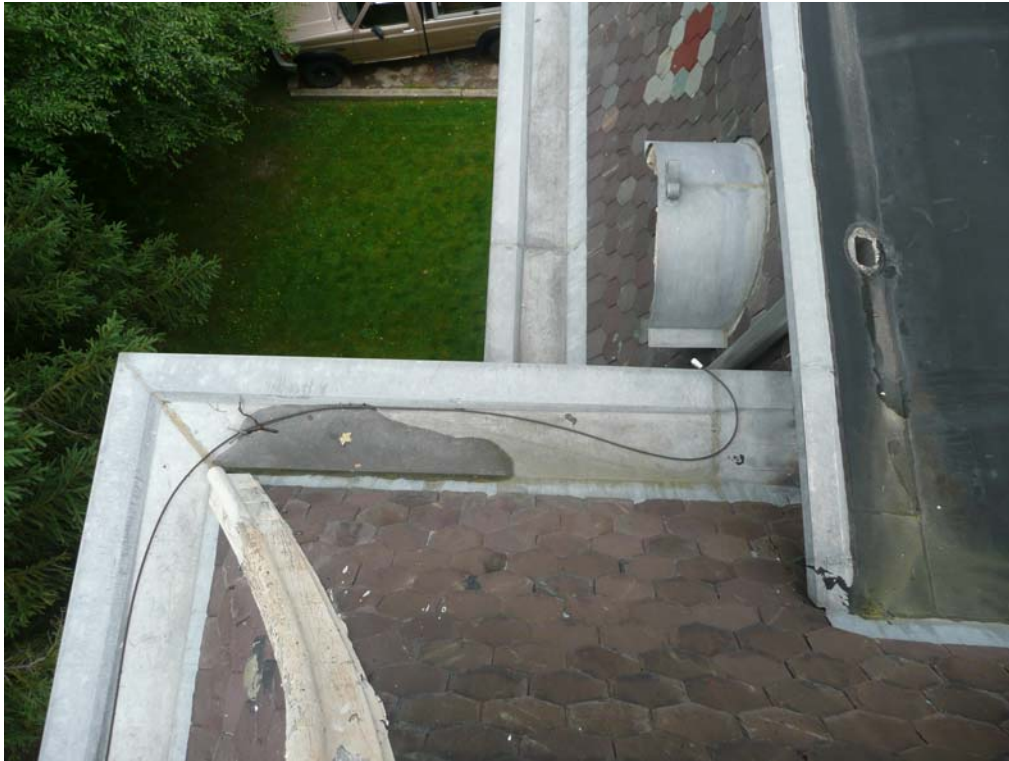
View of West Side of Intersection of Front and Rear Roofs looking North

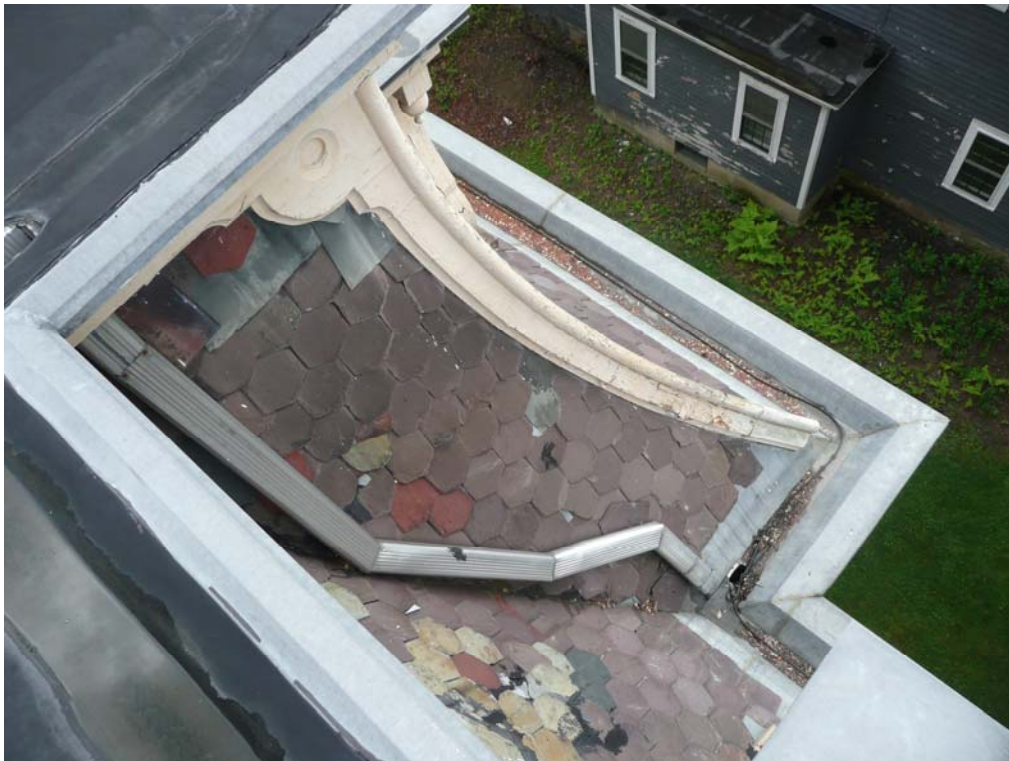
View of Northeast Corner of Front Roof

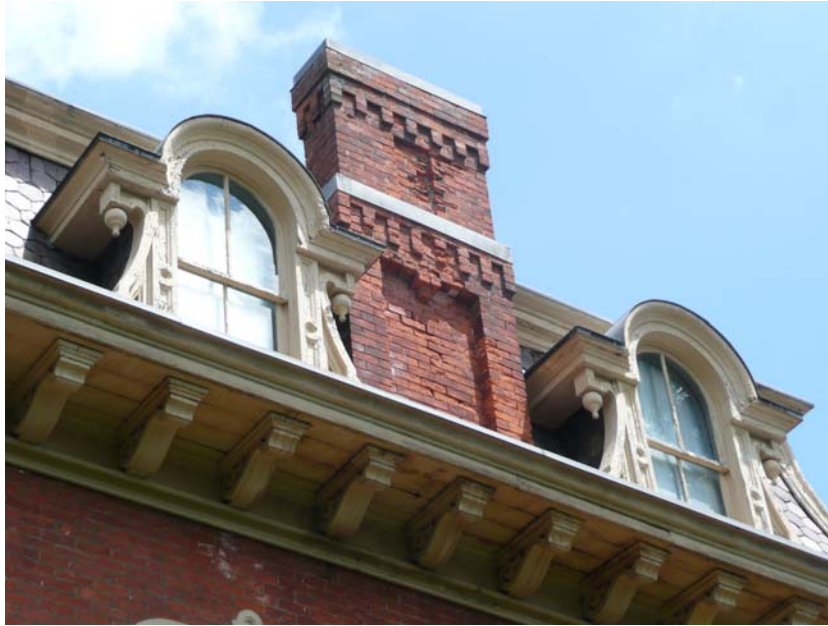
Typical Dormer at Front Roof (total of 8)

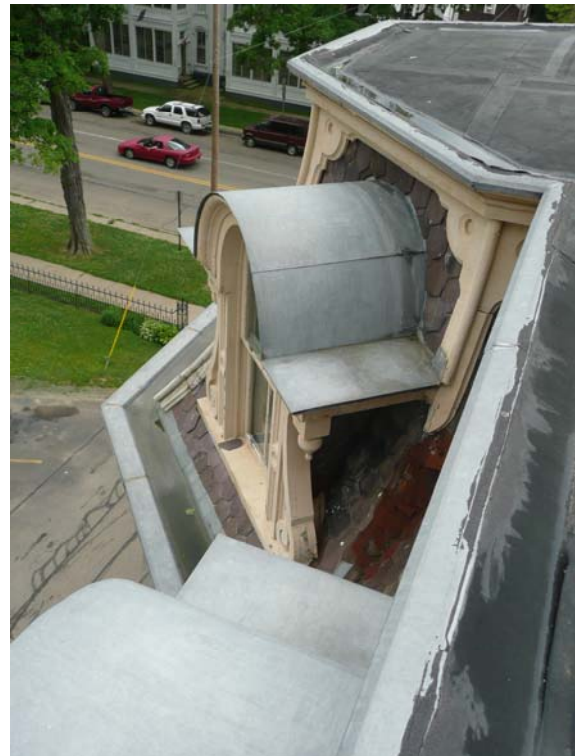
Overhead View of Typical Front Roof Dormer (east)

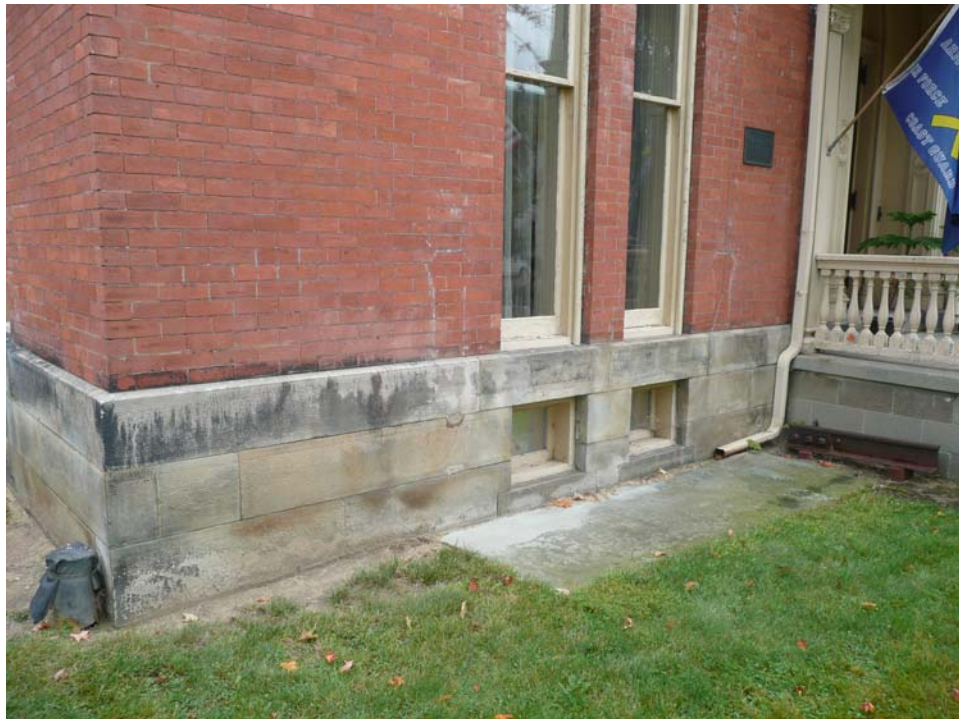
Typical Stone Foundation and Brick at Front of House

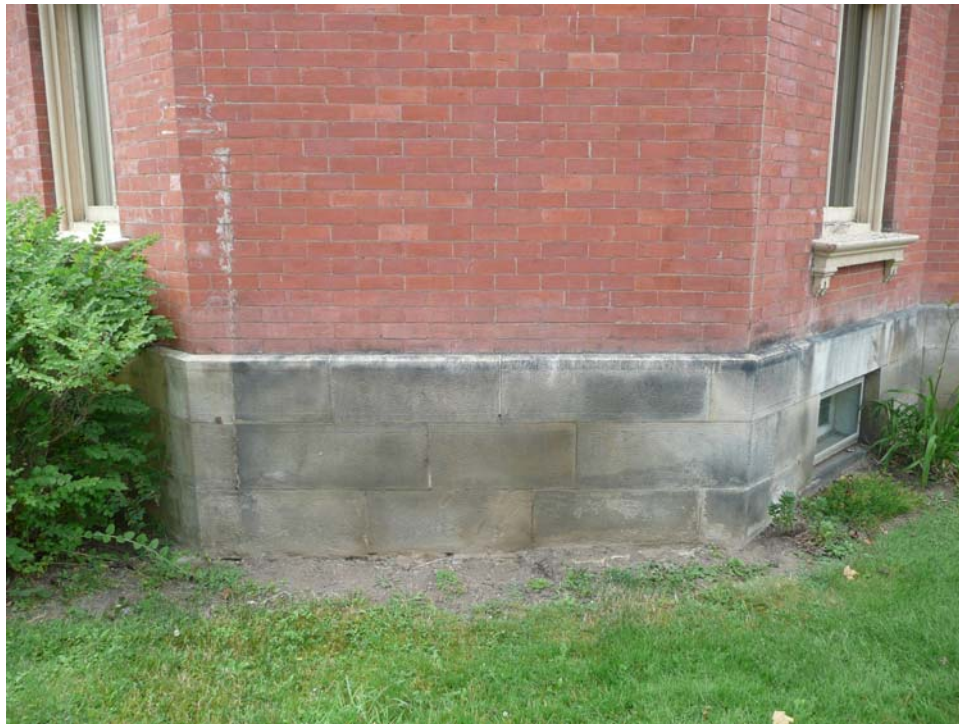
Typical Stone Foundation and Brick at Front of House

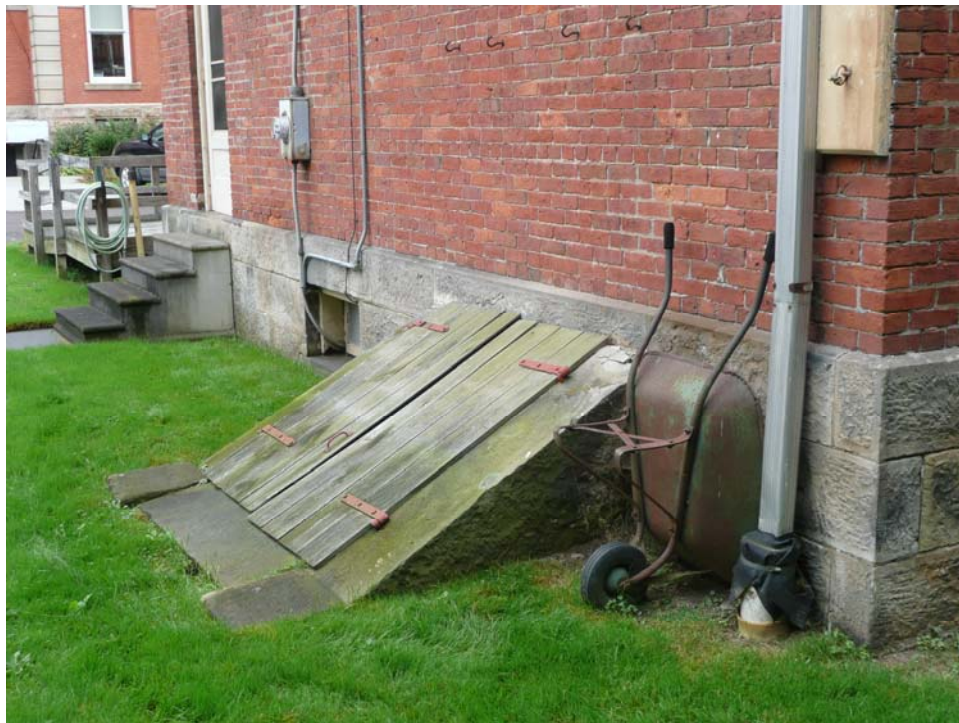
Typical Stone Foundation and Brick at Rear of House

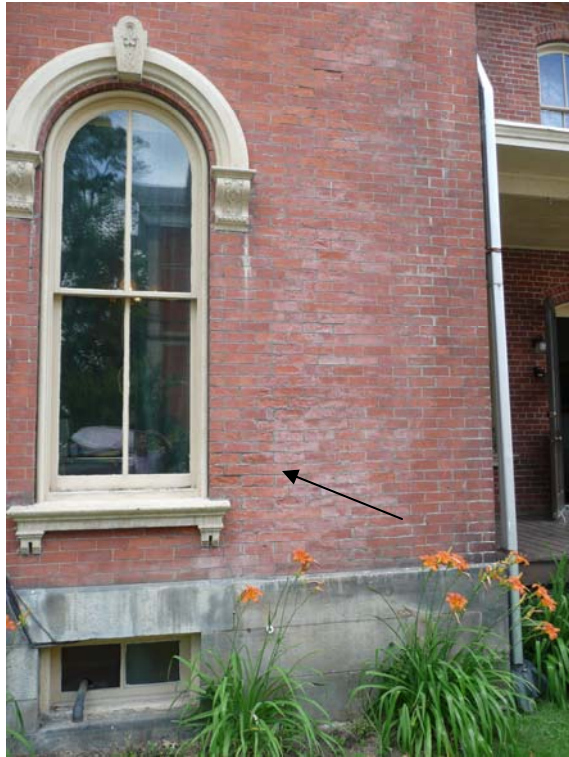
Damaged Brick at East Elevation (arrow)

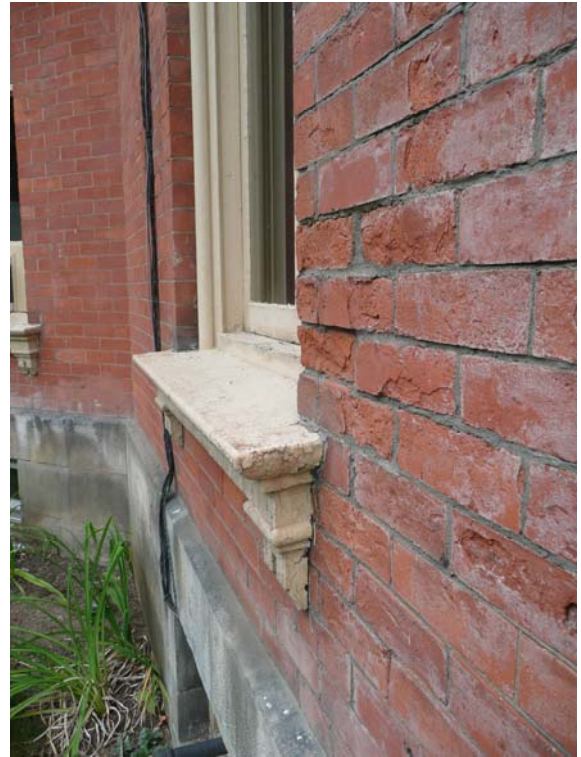
Detail of Damaged Brick at East Elevation

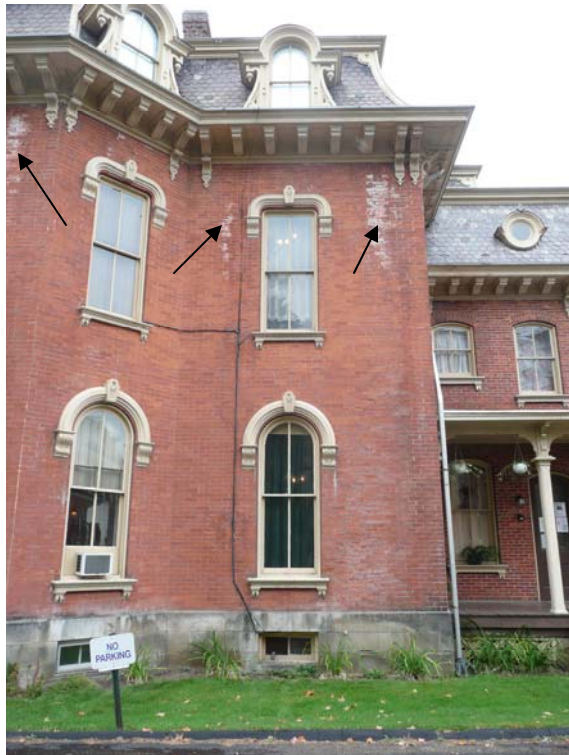
Efflorescence on Brick (arrows)

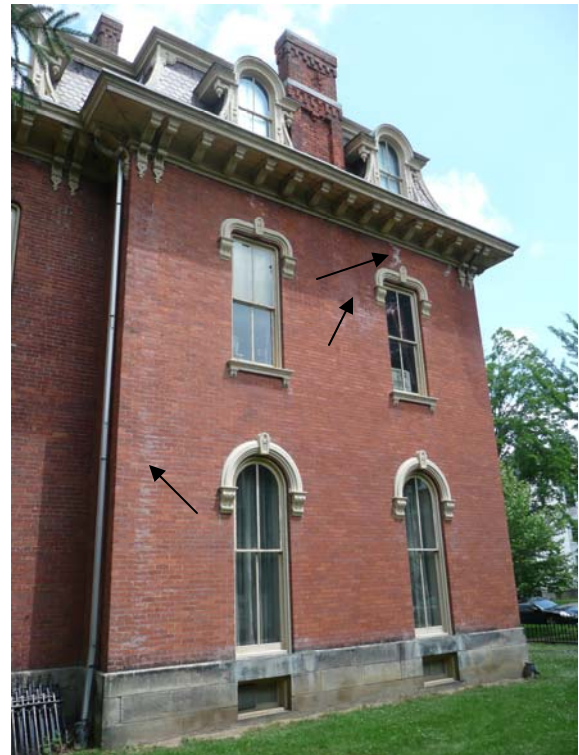
Efflorescence on Brick (arrows)

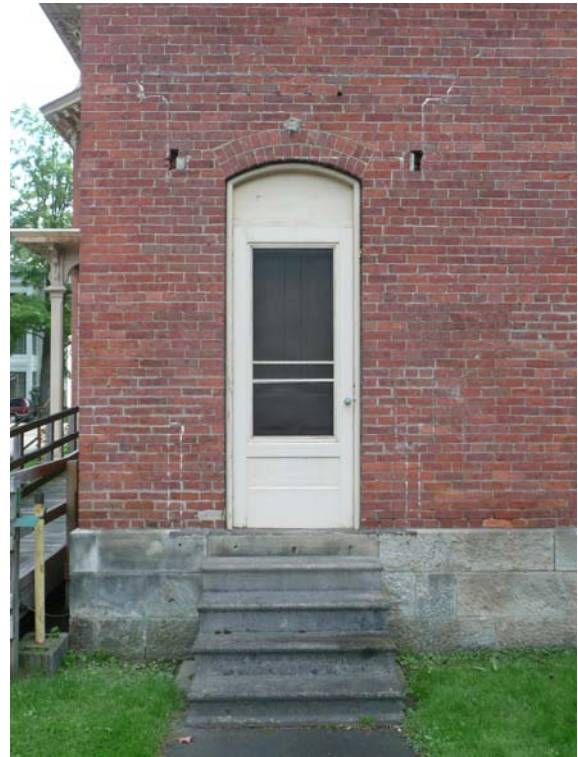
*North Entrance with Evidence of Missing
Projecting Covering and Railings*

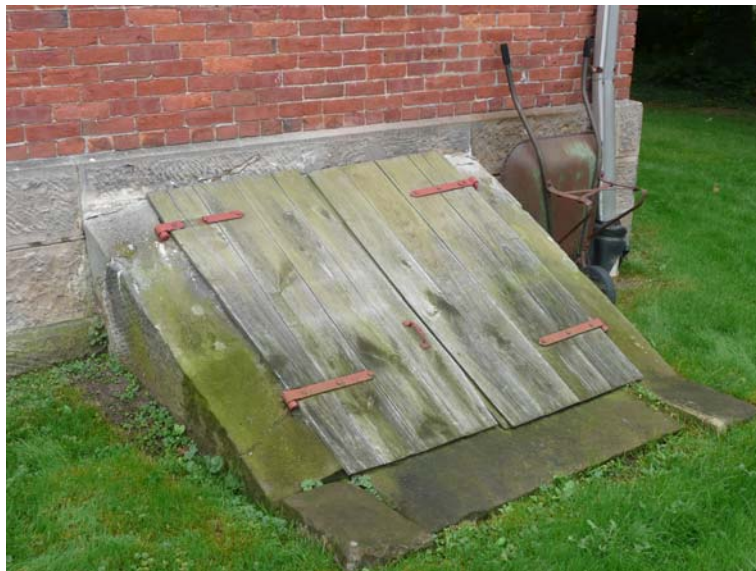
Exterior Entrance to Basement

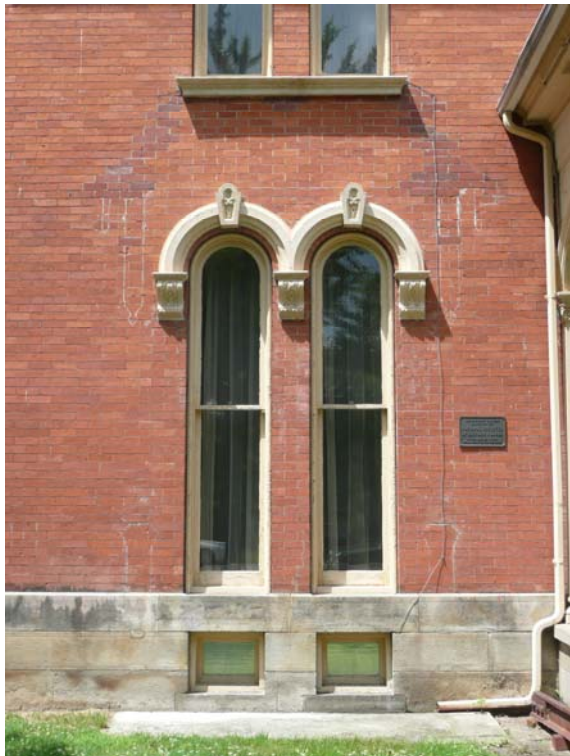
South Elevation – First Floor (total of 2 pair)

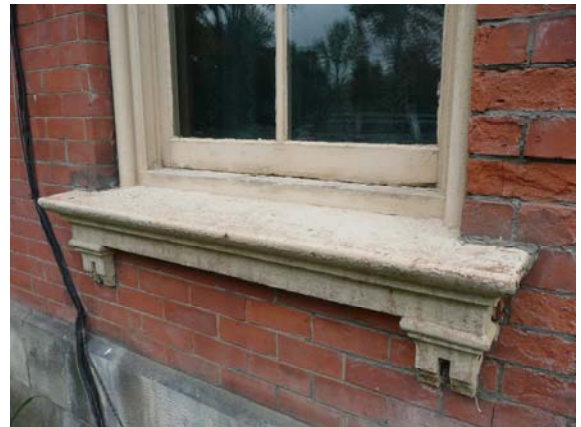
Typical Cast Iron Sill

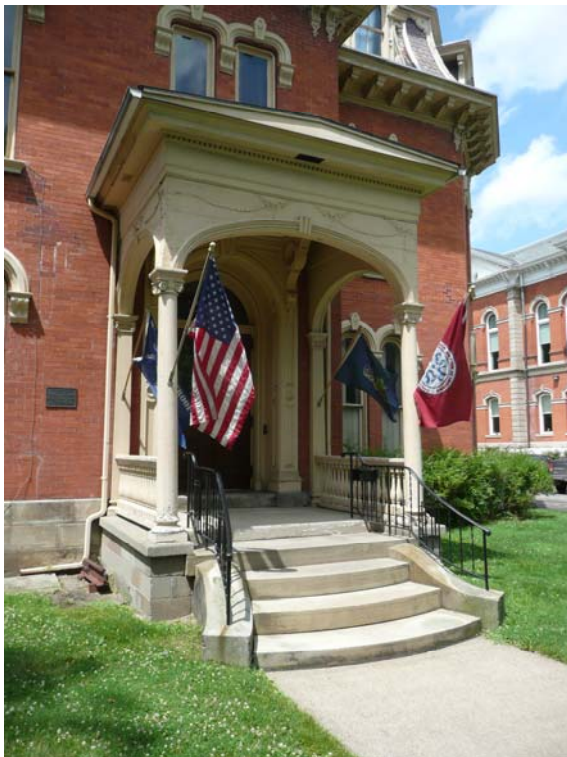
Front Entrance Porch looking North

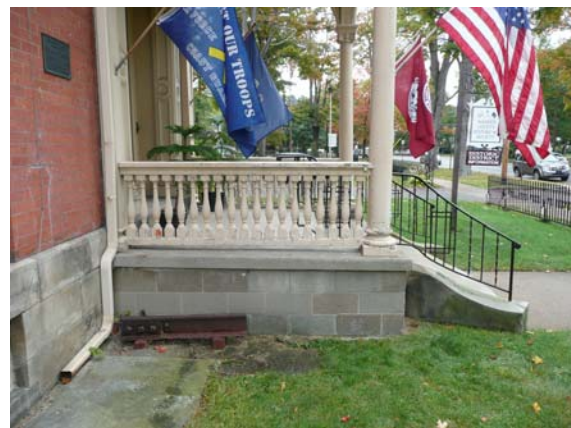
Close-up View of CMU Foundation

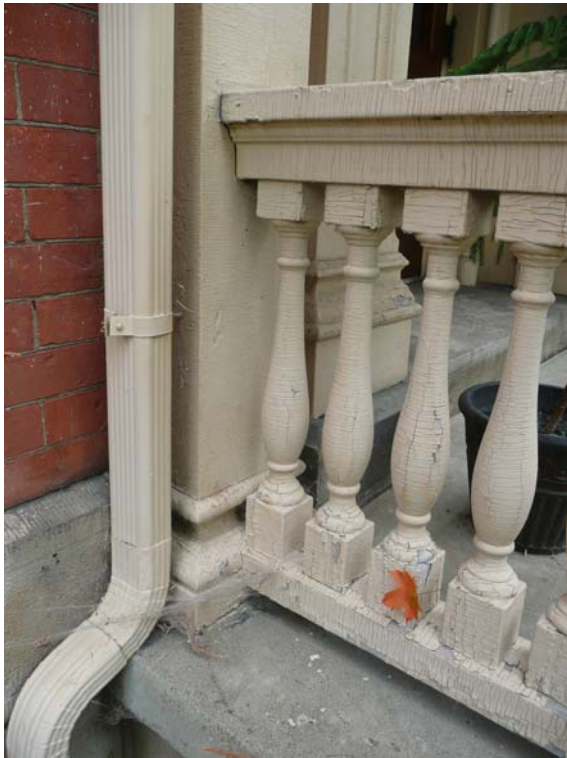
Detail of Railing and Pilaster

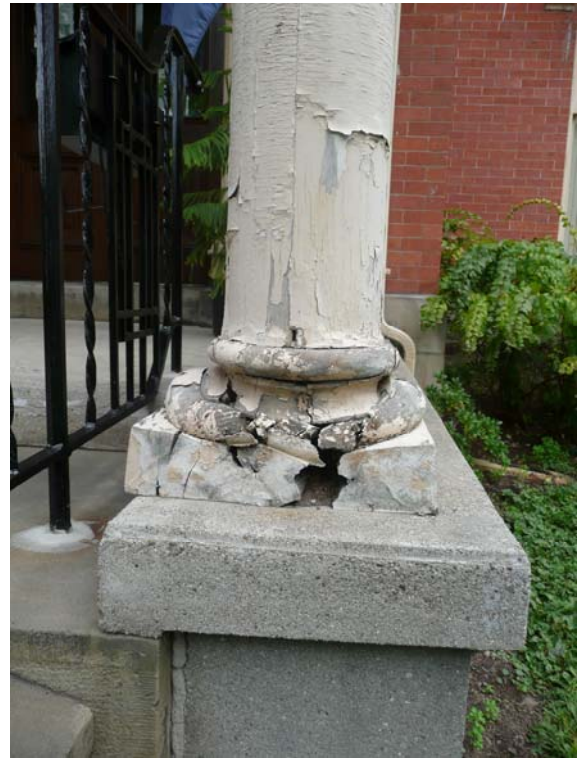
Detail of Deteriorated Column Base

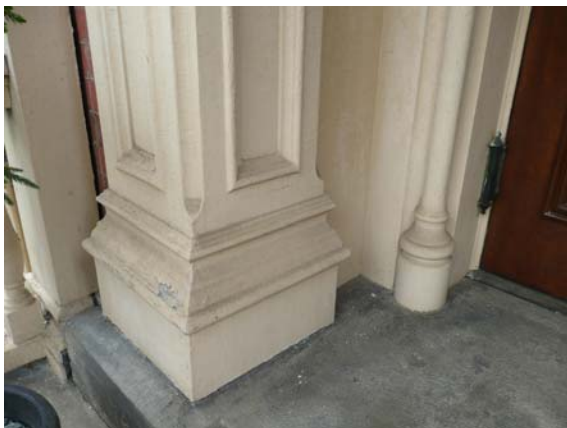
Detail of Recessed Door Frame

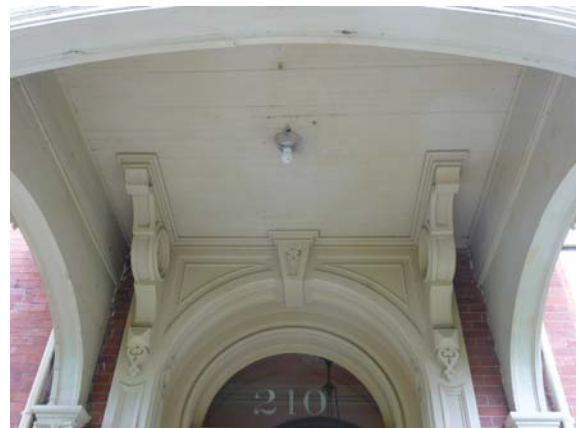
Detail of Door Frame and Brackets

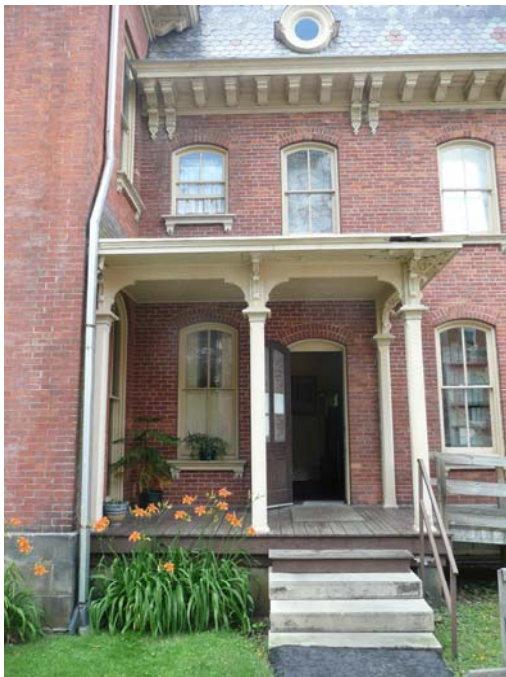
View of Porch 2 Looking West

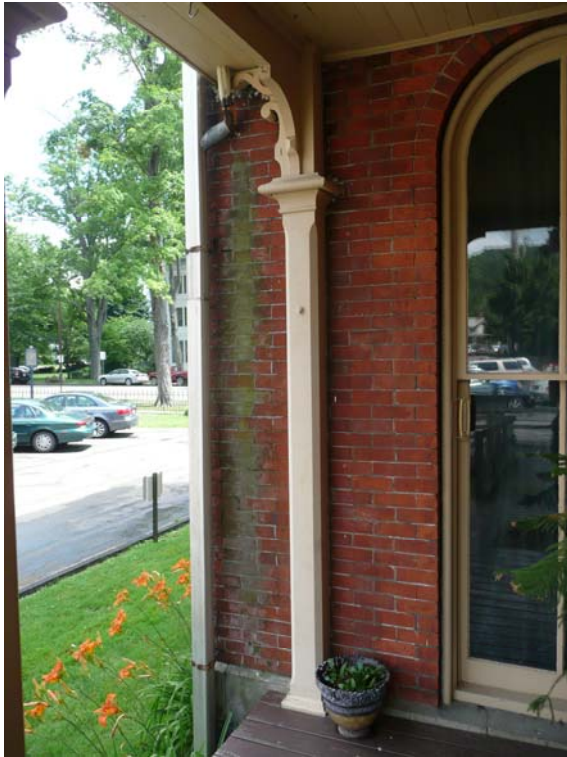
Detail of Porch – Downspout Leaking on Brick

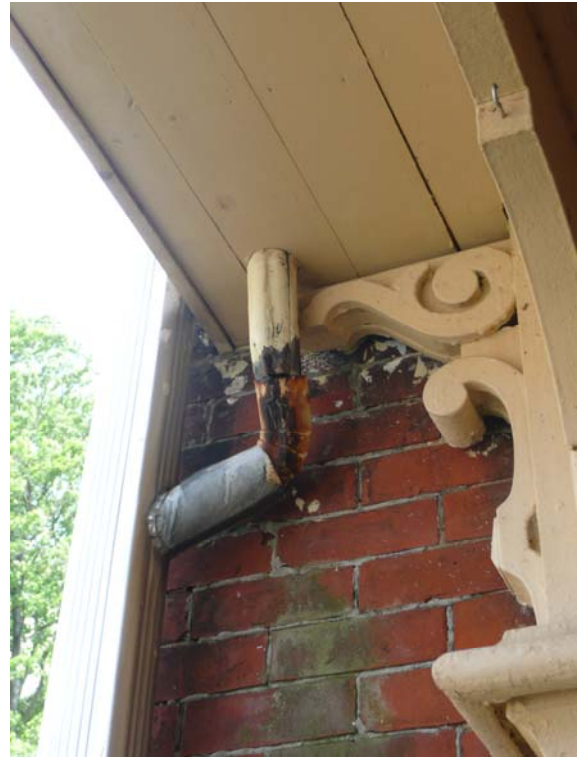
Deteriorated Downspout

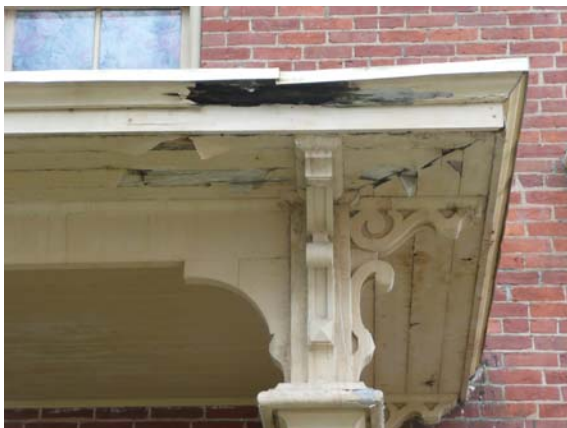
Detail of Damaged Wood from Leaking Roof

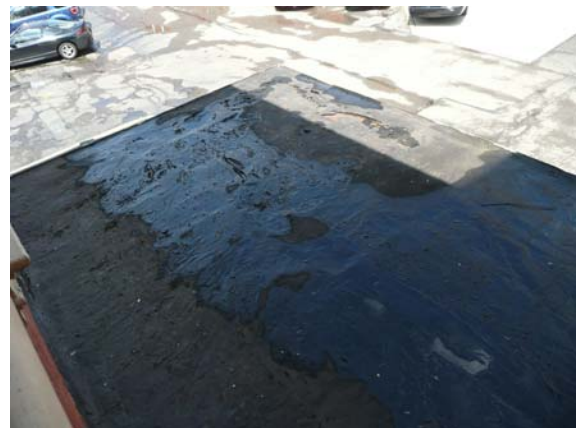
View of Porch Roof from Second Floor Window
