The Struthers-Wetmore-Schimmelfeng House Building Assessment and Preservation Plan

Warren County Historical Society

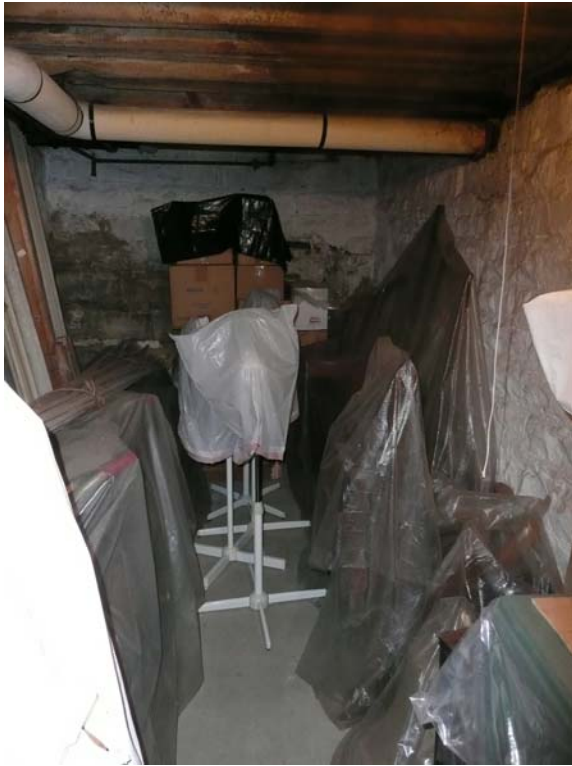
Assessment: Good condition
There is no standing water, but air feels damp

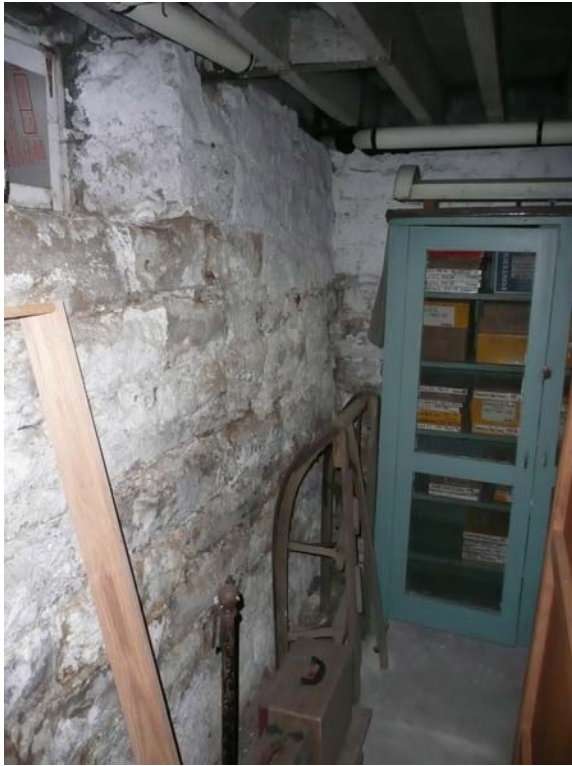
View of Southwest Corner of Room

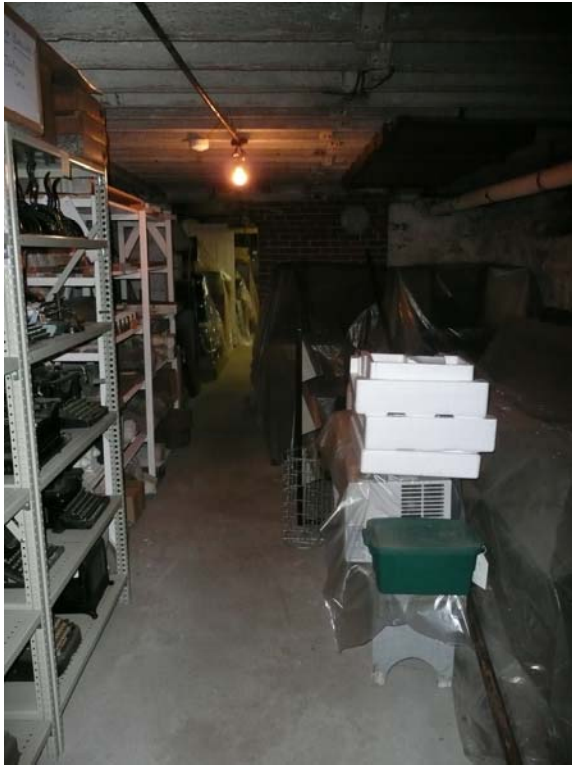
Assessment: Good condition. Floor and walls should be repainted.
There is no standing water, but air feels damp

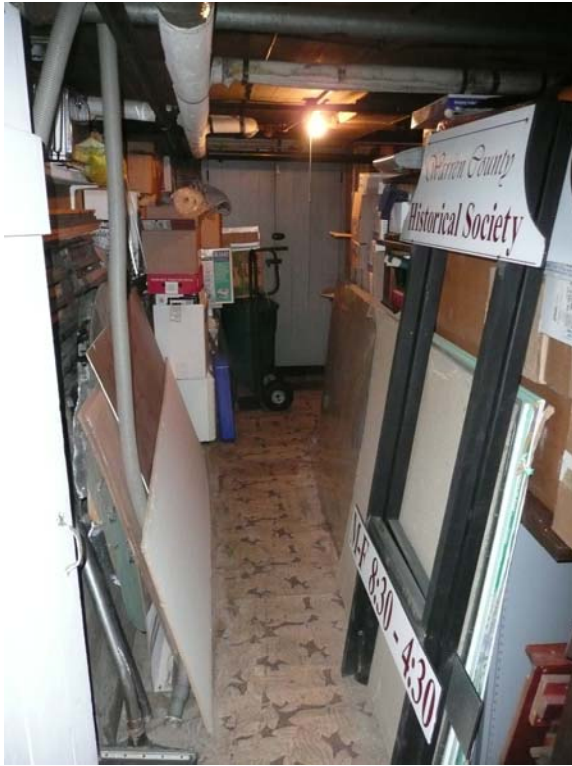
View Looking North at Doors to Exterior Stair

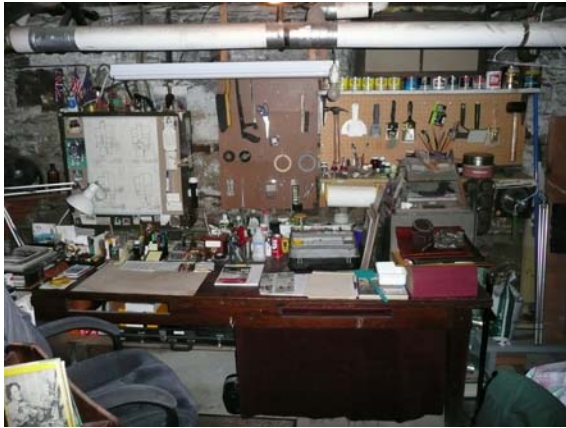
Assessment: Fair condition. Walls need repaired and painted.
There is no standing water, but air feels damp

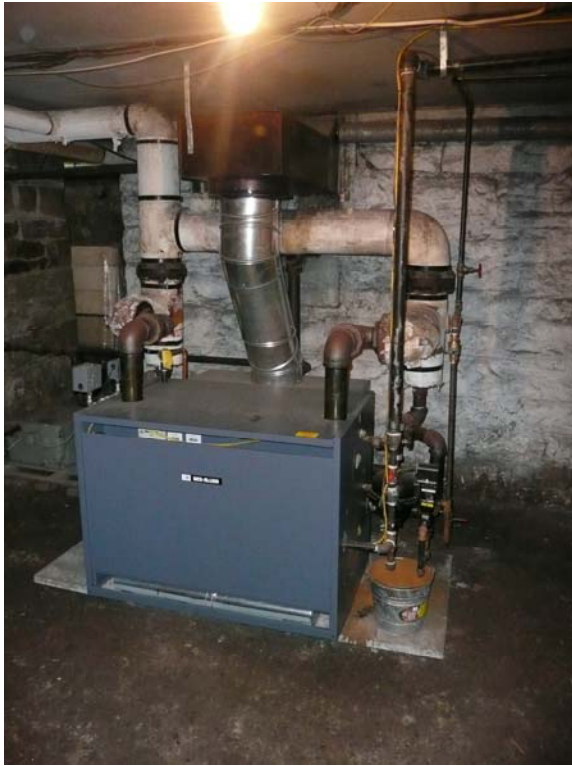
View of Steam Boiler

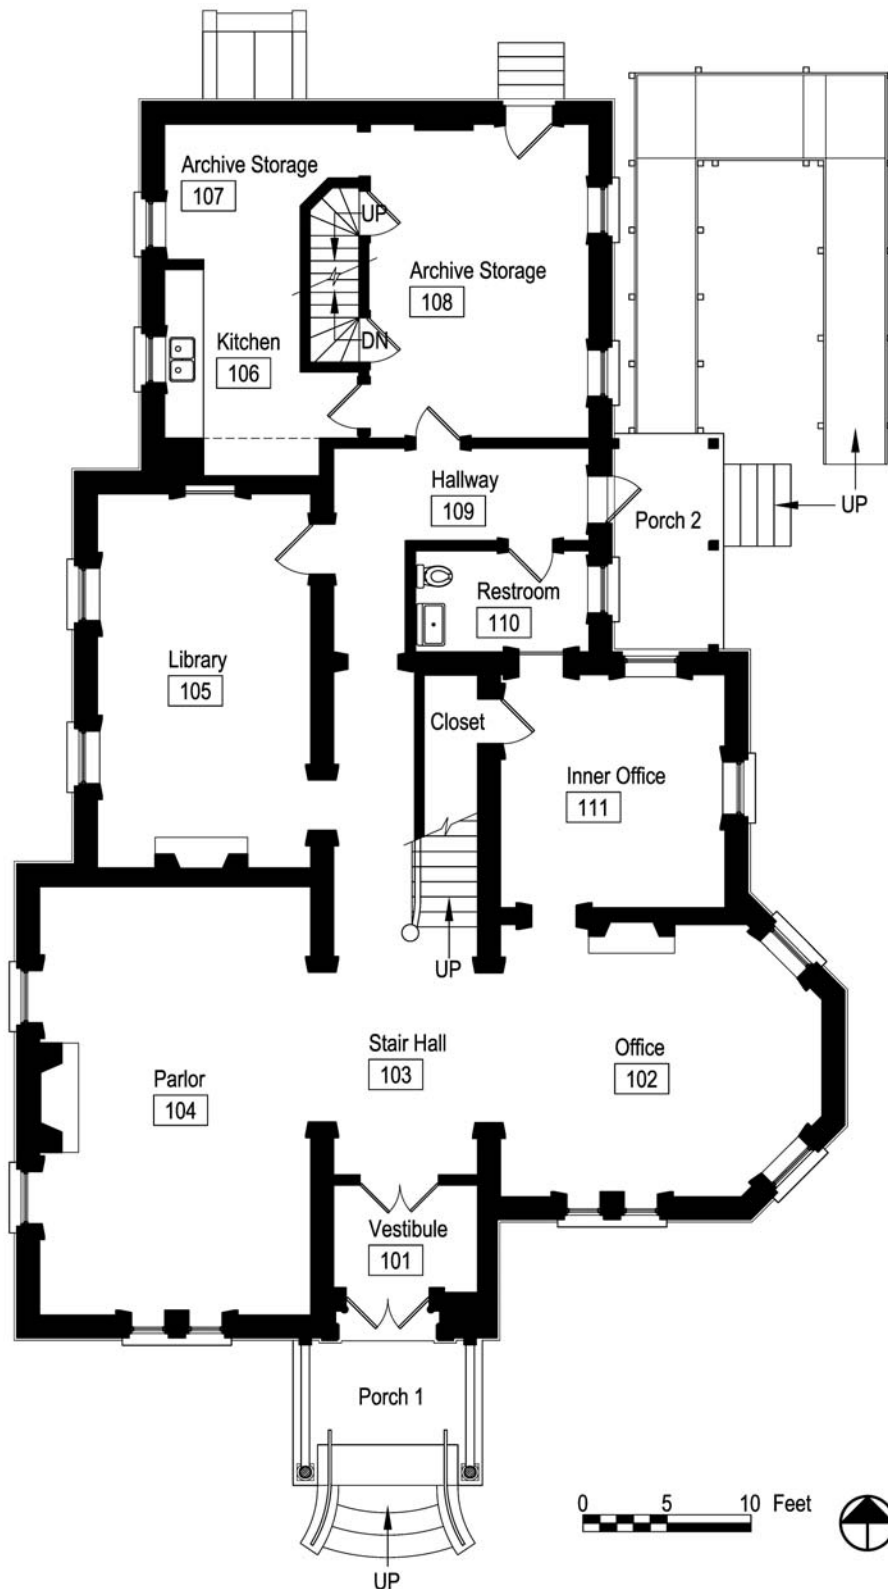
9. FIRST FLOOR DESCRIPTION

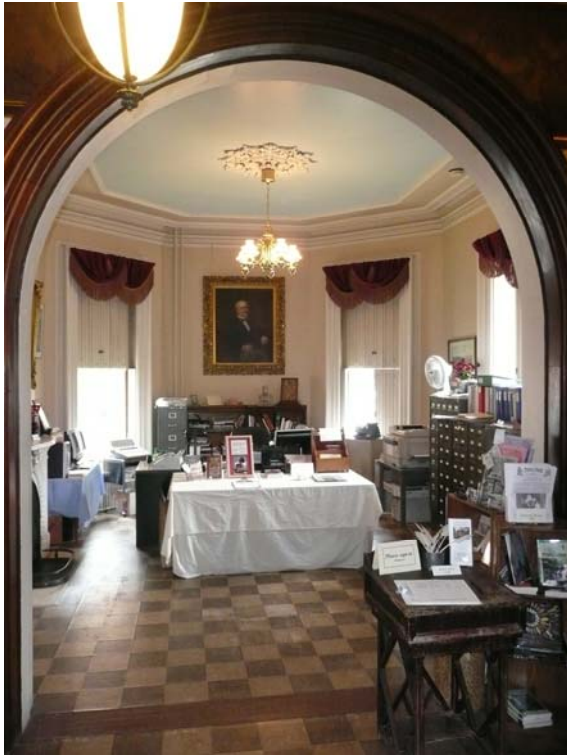
View from Stair Hall

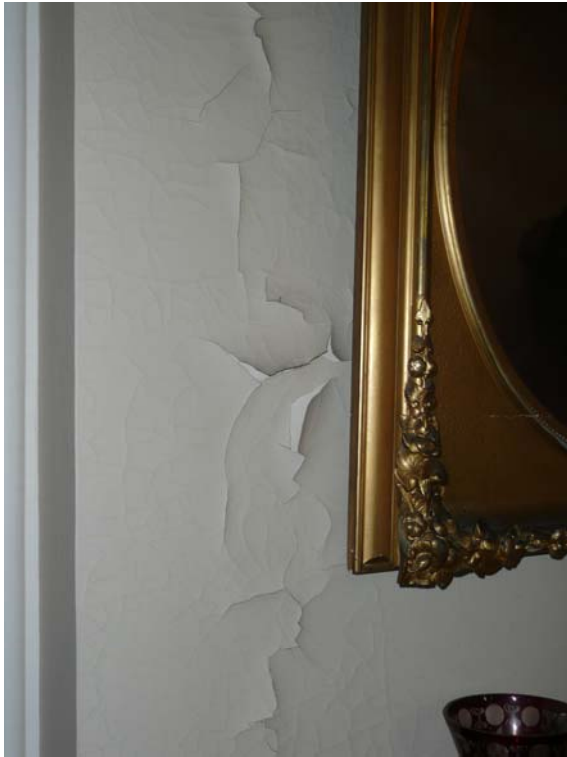
Deterioration of Wall Finish at Fireplace

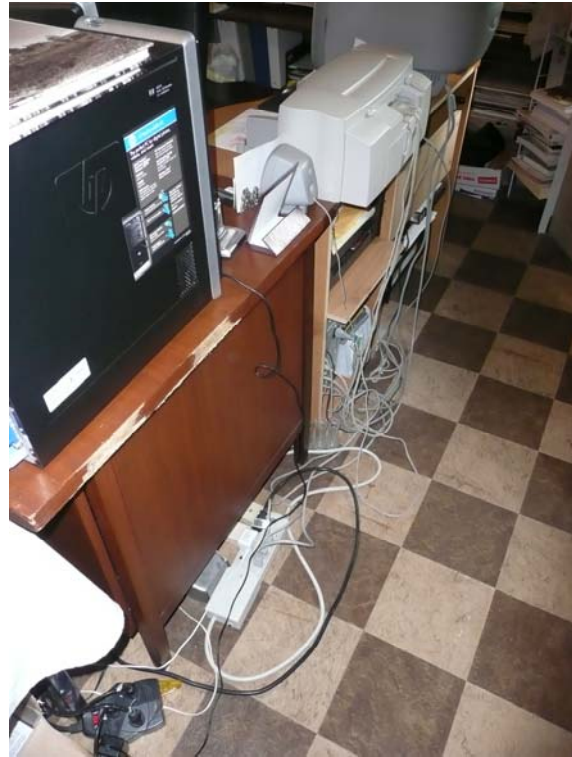
Electrical and Data Wiring

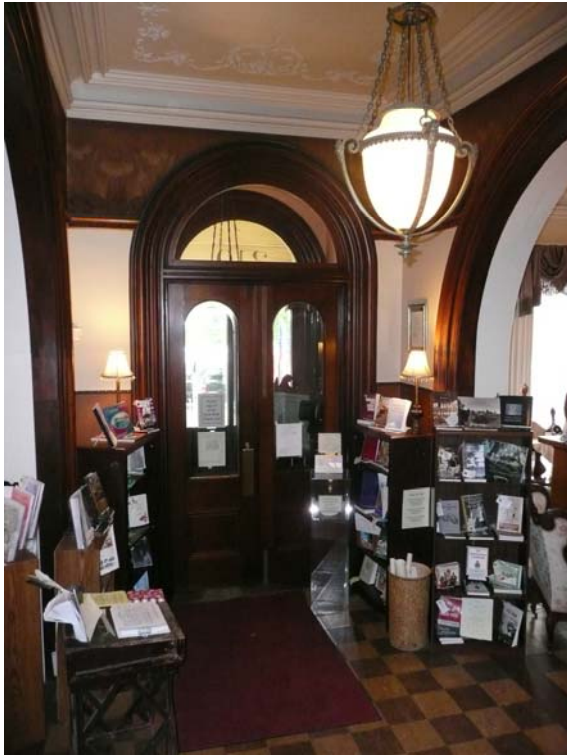
Looking South at Front Doors

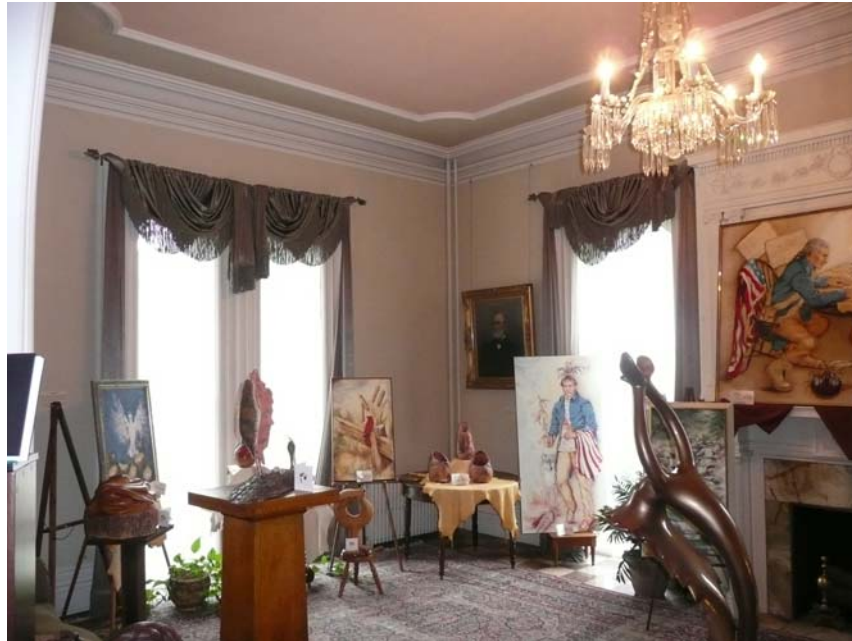
View Looking Southwest

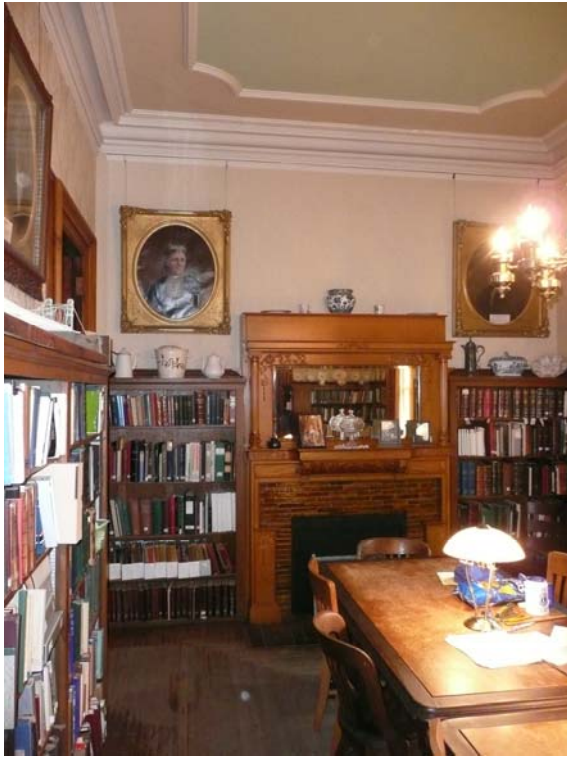
View Looking South at Fireplace

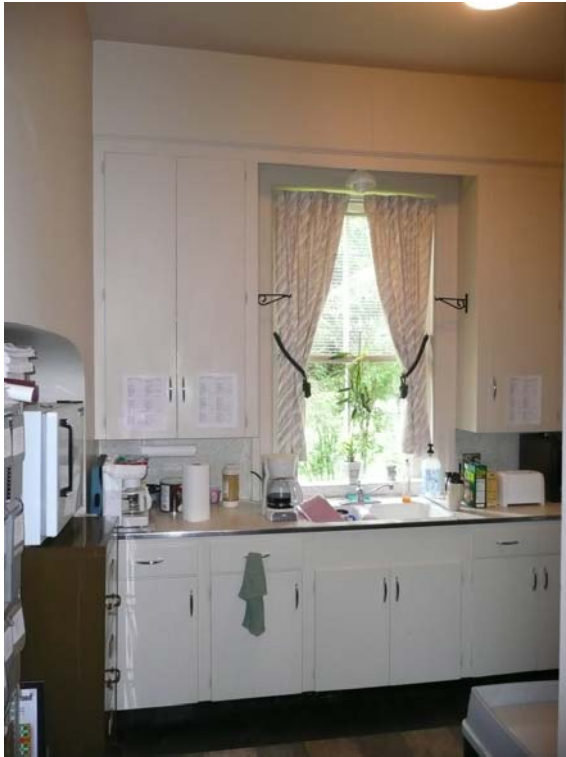
Assessment: Overall good condition is good.
Painted surfaces could be repainted and stained surfaces washed
Electrical system should be updated

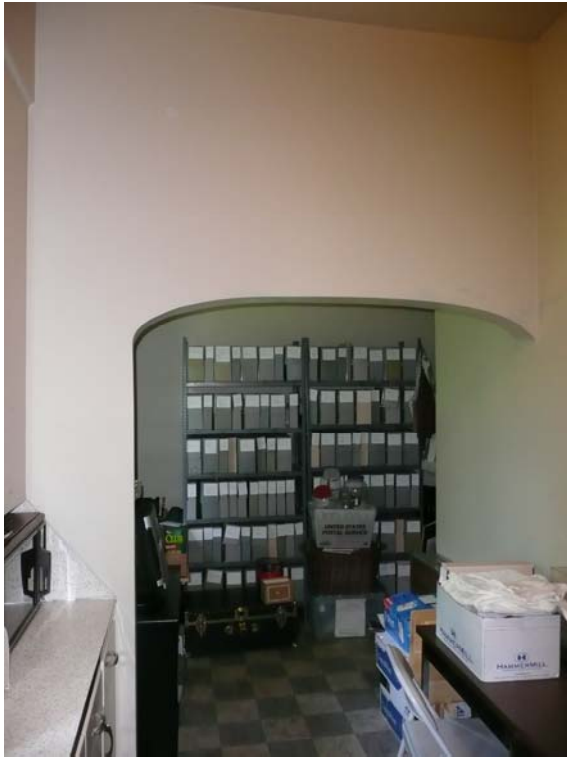
View Looking North from Kitchen

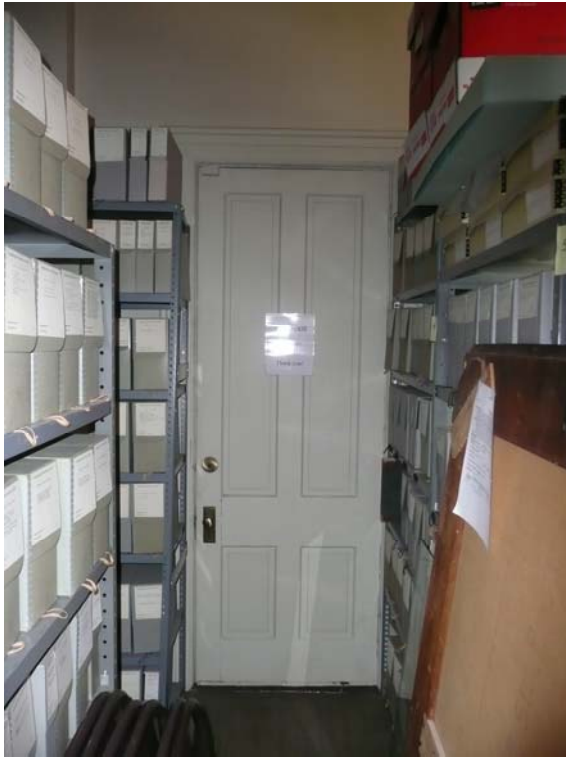
View Looking North at Exit Door to Exterior

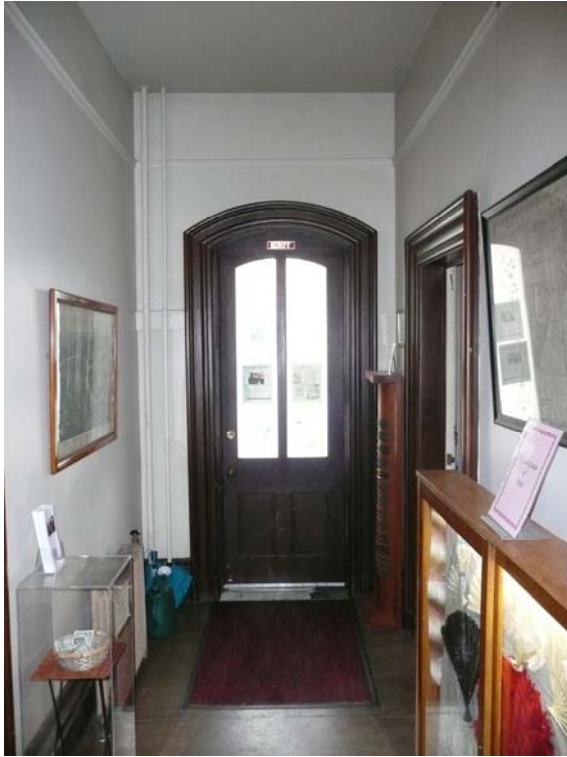
View Looking East at Exterior Door to Porch 2

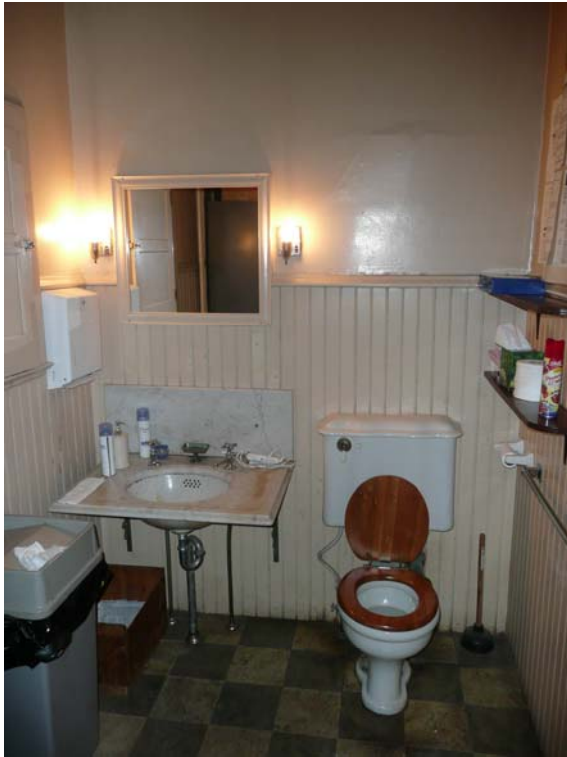
Assessment: Overall good condition is good.
Painted surfaces could be repainted
Flooring not historically correct
Electrical system should be updated

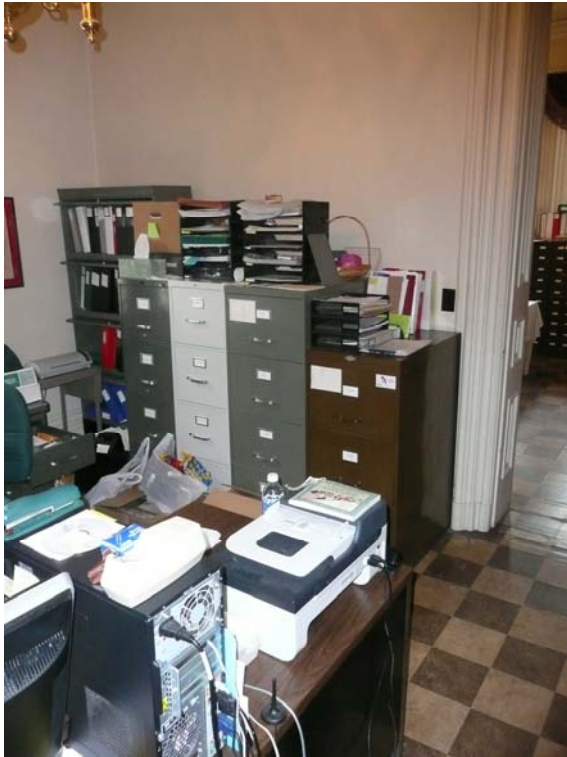
Assessment: Overall functional condition, but not handicap accessible
Painted surfaces need to be repaired and repainted
Flooring not historically correct
Electrical system should be updated
Install an exhaust fan

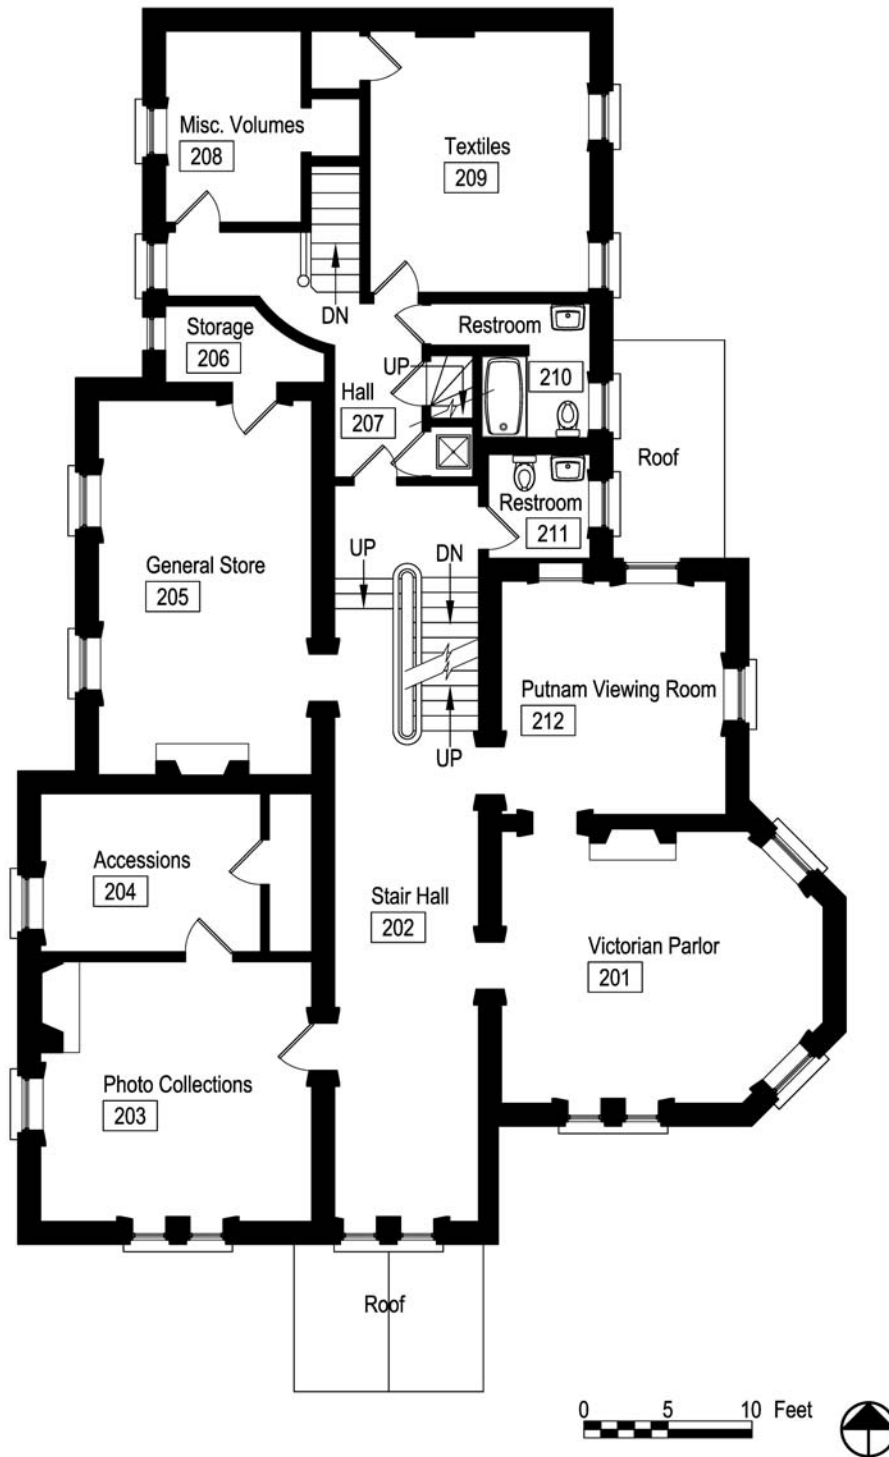
10. SECOND FLOOR DESCRIPTION

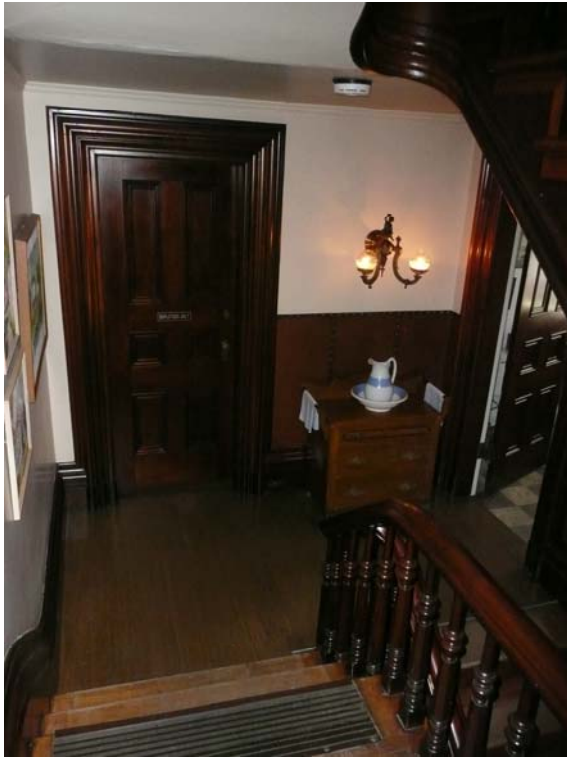
View Looking North at Stair Landing

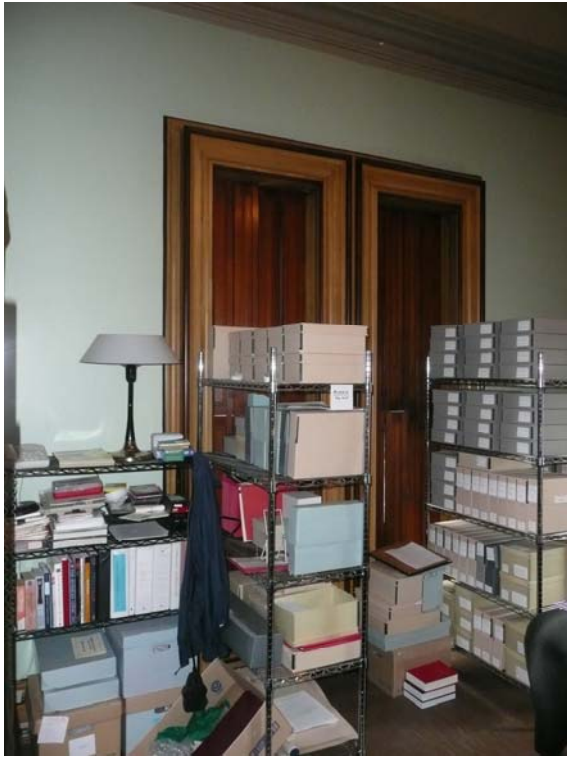
View Looking South at Front Windows

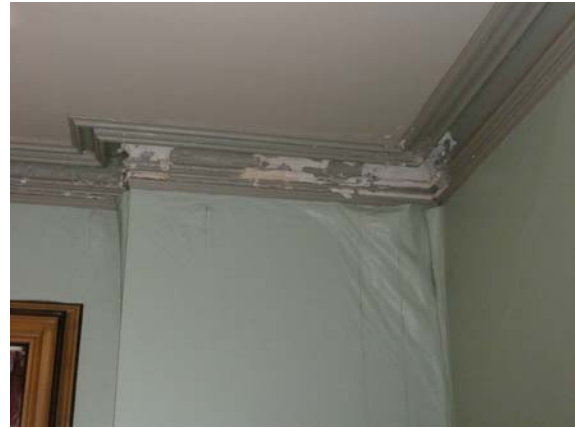
Detail of Water Damaged Plaster at Chimney

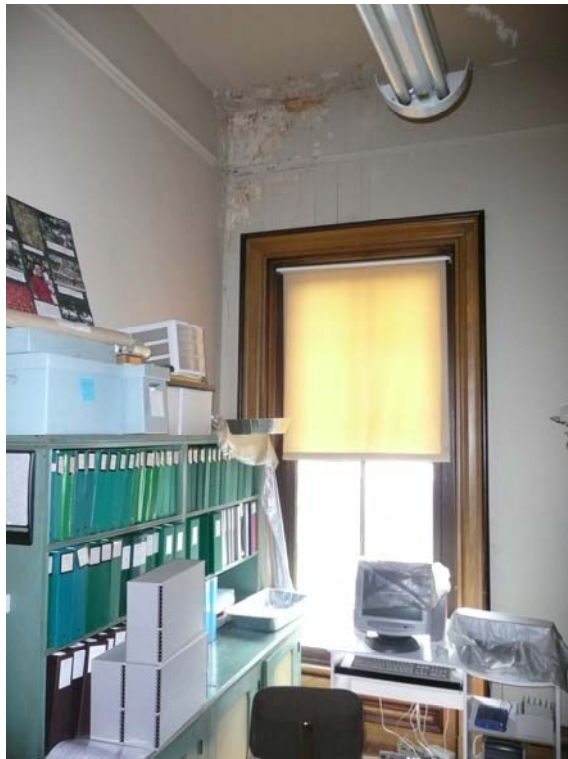
Assessment: Fair condition
Light fixture and flooring are not historically correct
Plaster walls, ceiling and cornice water damaged over fireplace
Fix roof leak, let plaster dry out, repair plaster and repaint entire room
Update electrical systems

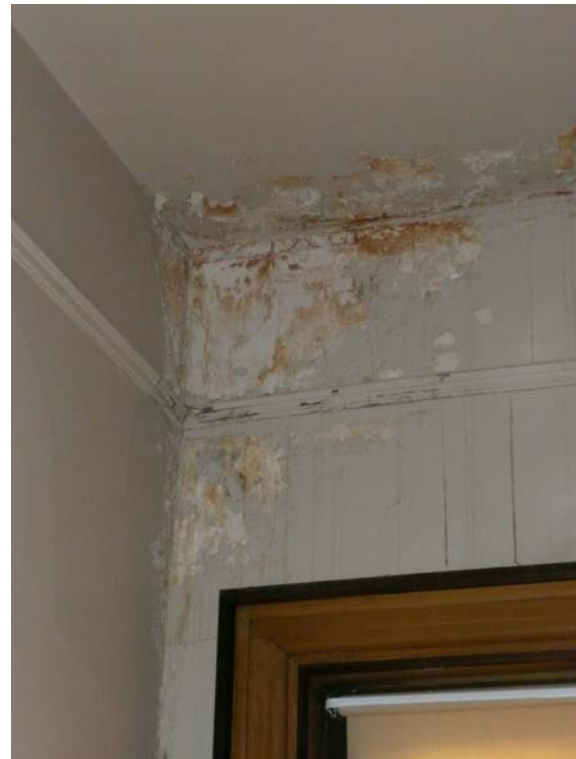
Detail of Water Damaged Plaster at West Wall

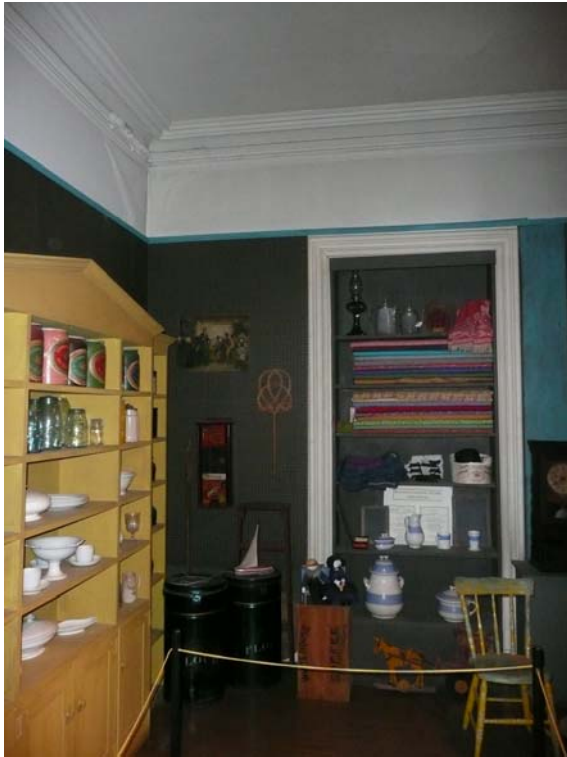
Assessment: Fair condition
Light fixture is not historically correct
Plaster walls and ceiling are water damaged over window
Fix roof leak, let plaster dry out, repair plaster and repaint entire room
Update electrical systems

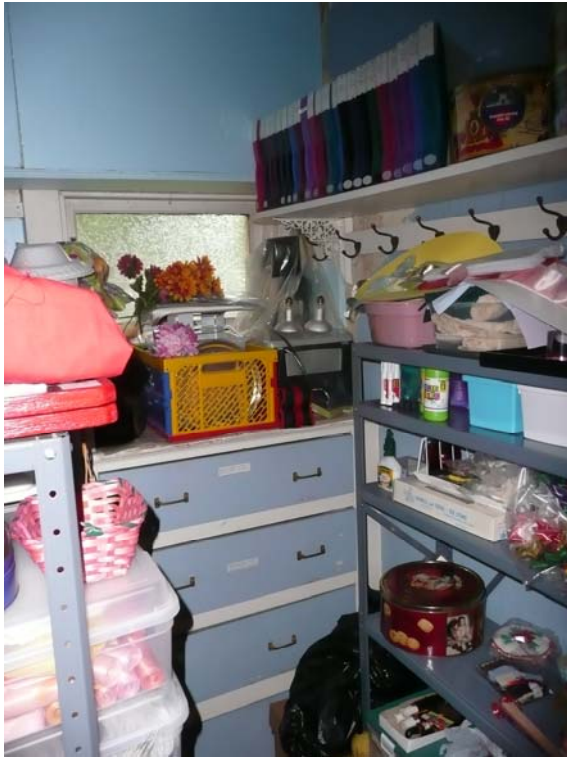
Assessment: Overall good condition
Light fixture and flooring are not historically correct
Plaster walls and ceiling are water damaged at southwest corner of room
Fix roof leak, let plaster dry out, repair plaster and repaint
Update electrical systems

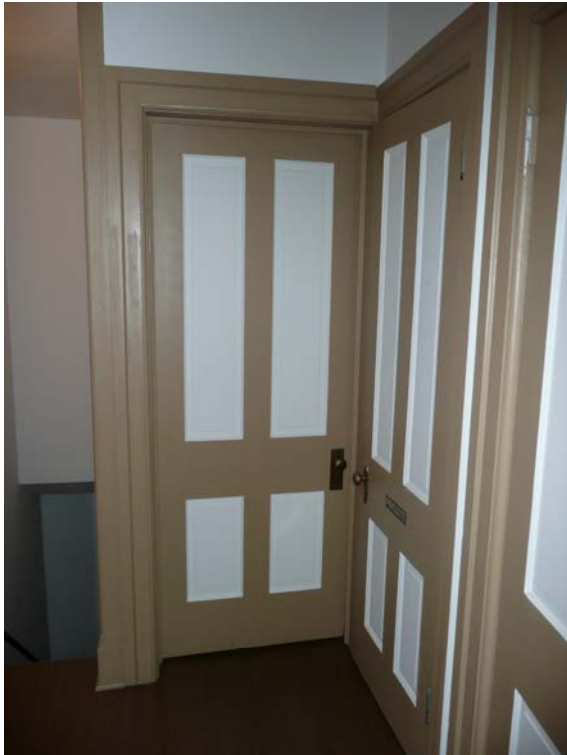
Room 207 – Hallway (Original Use – Same)

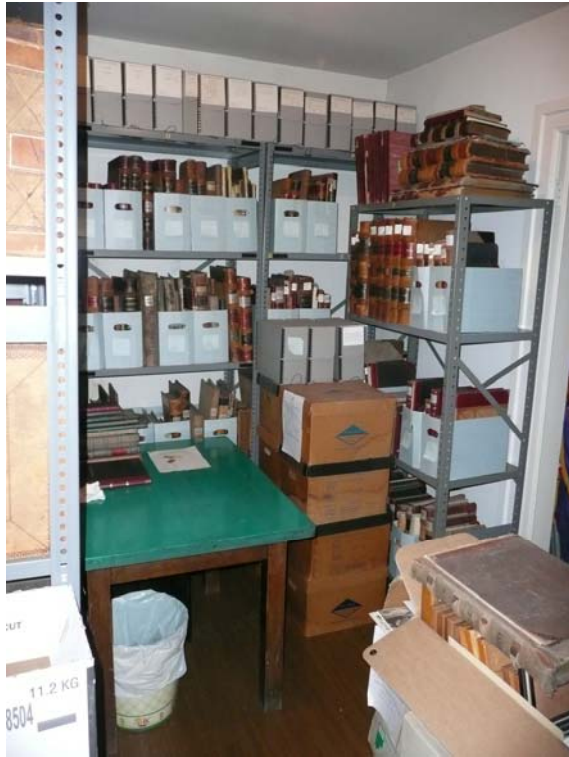
Assessment: Good overall condition
Flooring and light fixtures are not historically correct
Plaster walls and ceiling are water damaged at southwest corner of room
Fix roof leak, let plaster dry out, repair plaster and repaint
Update electrical systems

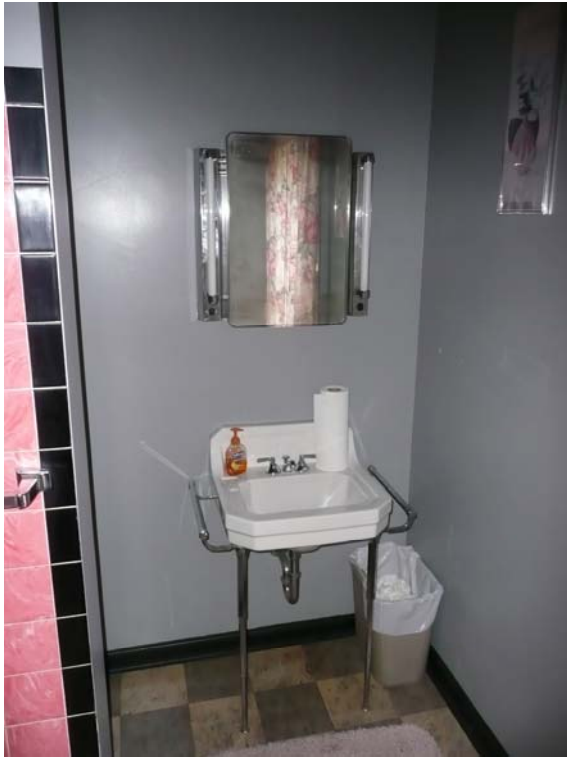
Assessment: Good overall condition
Flooring and light fixtures are not historically correct
Update electrical system

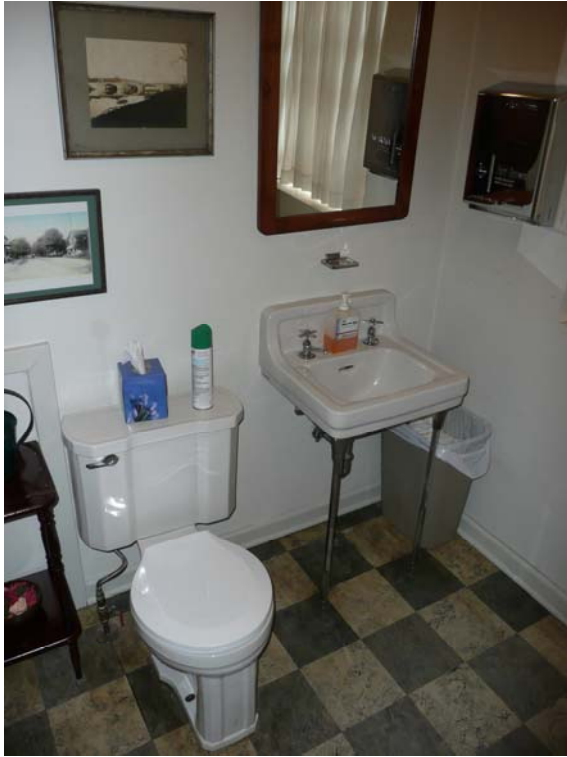
Assessment: Good overall condition
Bathroom appears to have been remodeled in the 1940's
Update electrical system
Install an exhaust fan

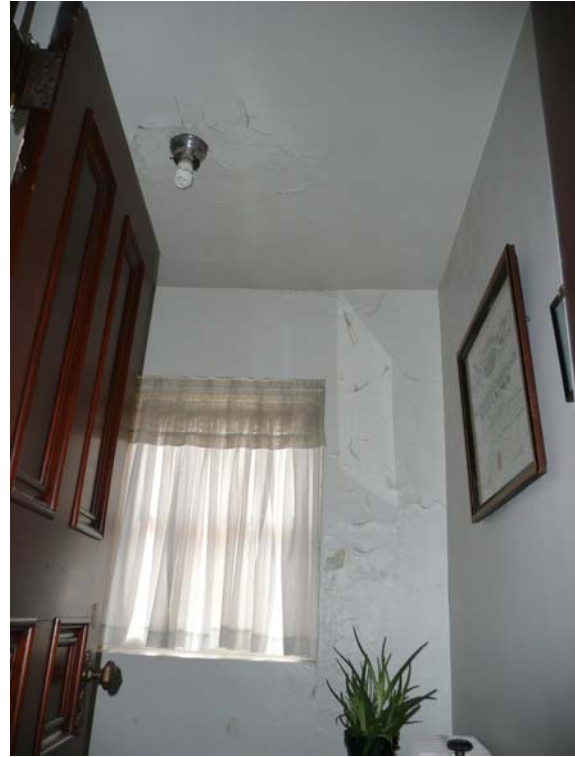
View Looking East at Water Damaged Plaster

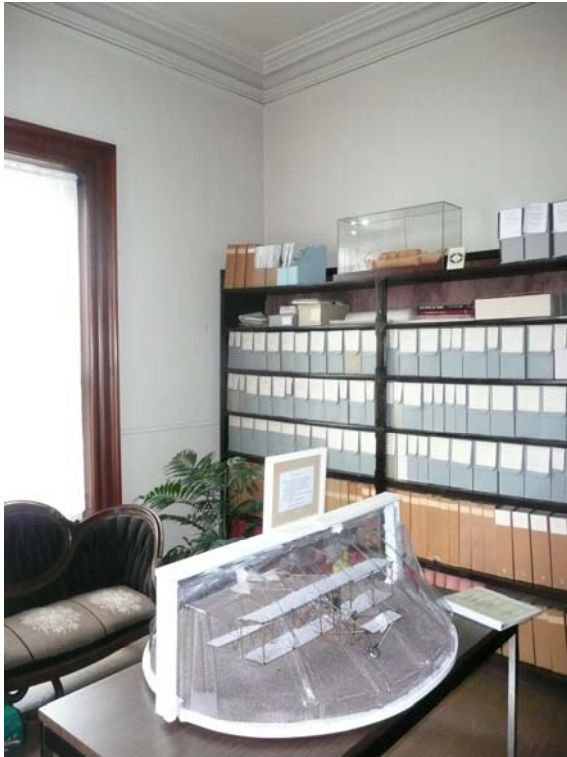
View Looking Southeast

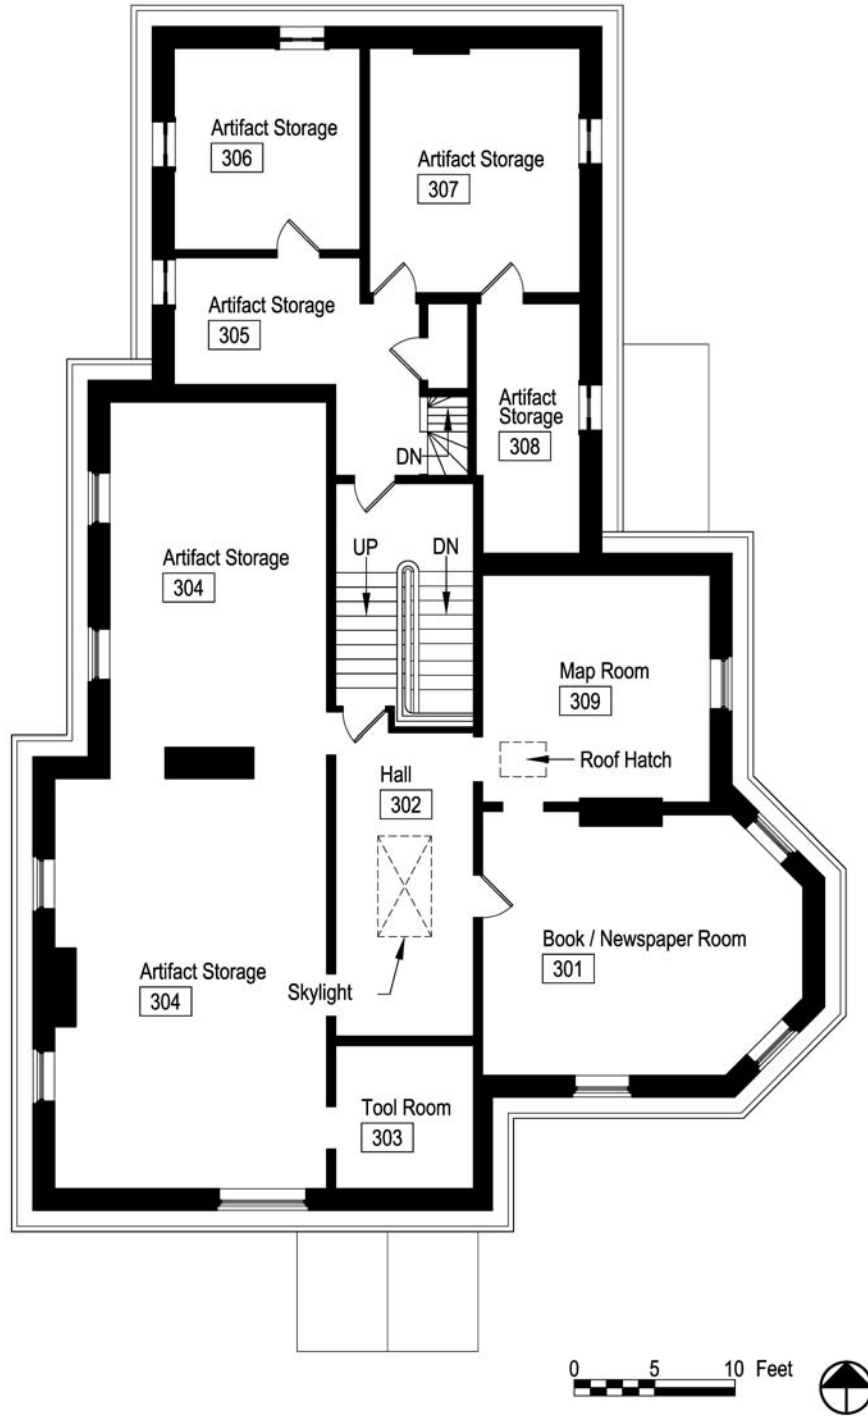
11. THIRD FLOOR DESCRIPTION

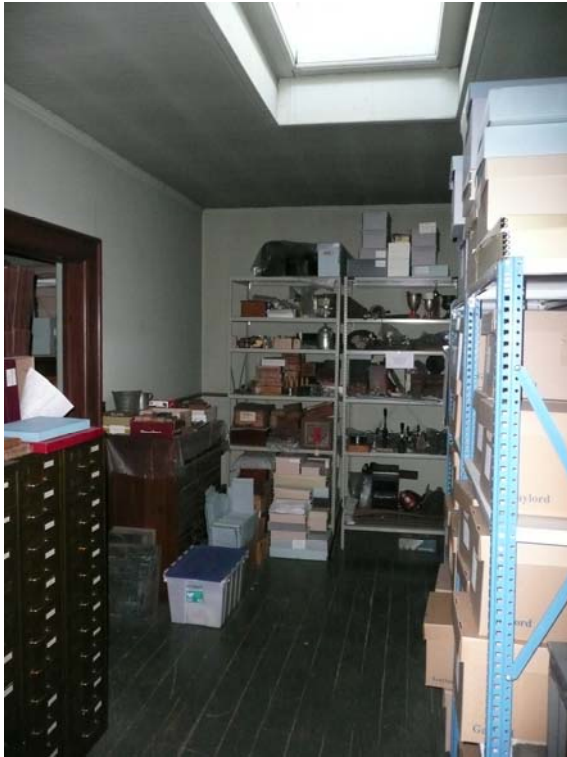
Assessment: Overall fair condition
Repair damaged plaster and repaint
Update electrical system

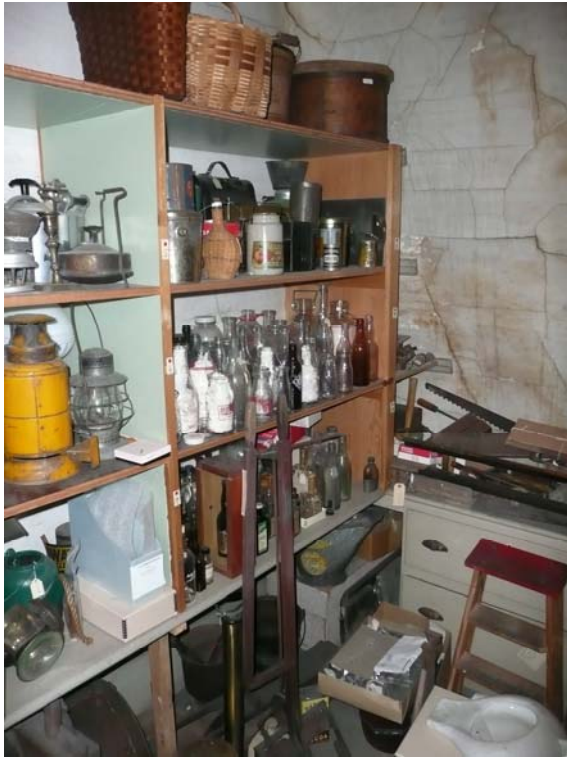
View Looking Northeast

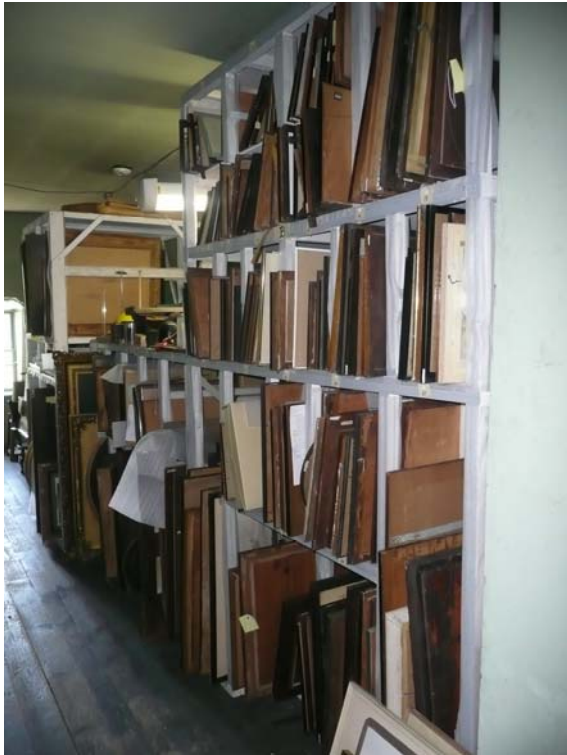
Room 304 – Artifact Storage

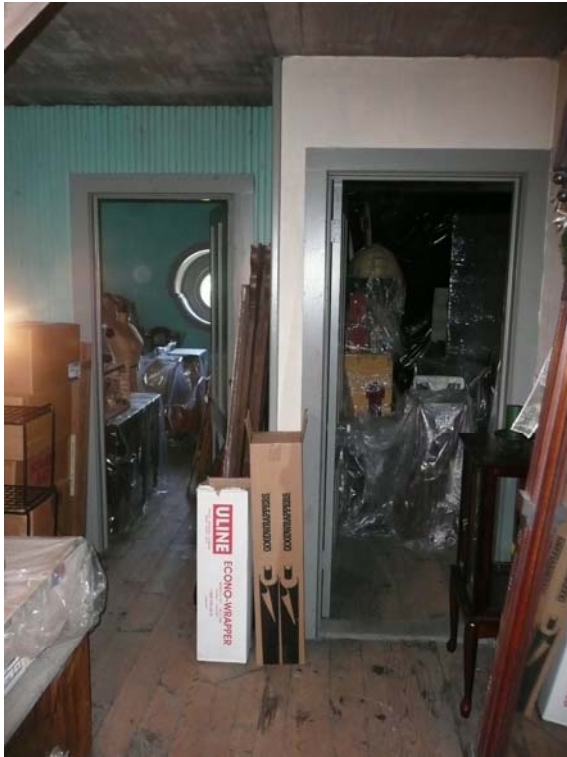
Room 305 – Artifact Storage

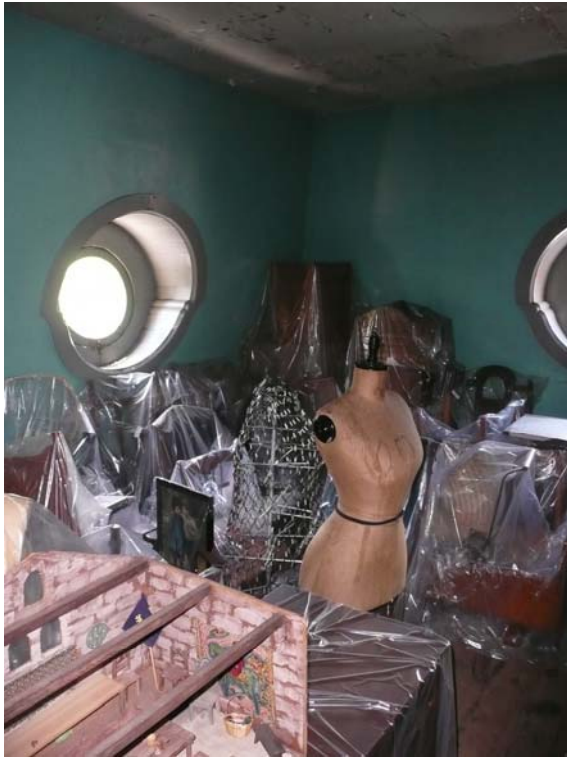
View Looking Northwest

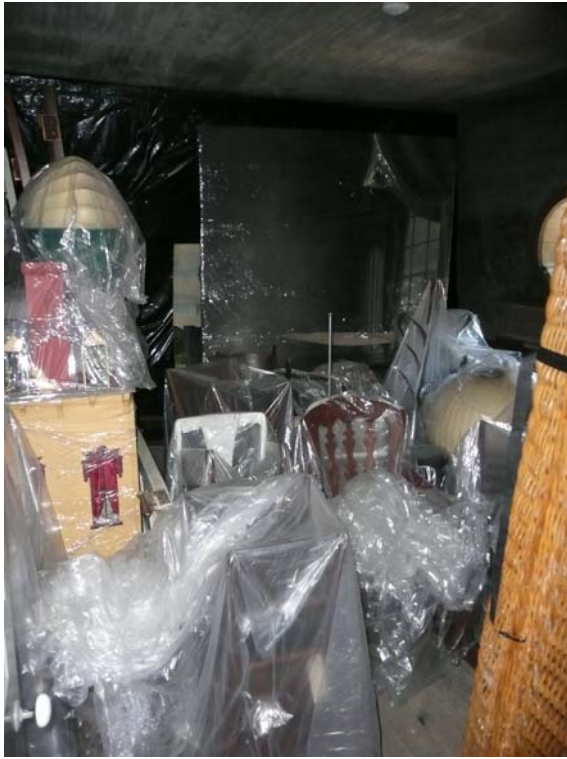
Assessment: Overall fair condition
Repair damaged plaster and paint
Update electrical system

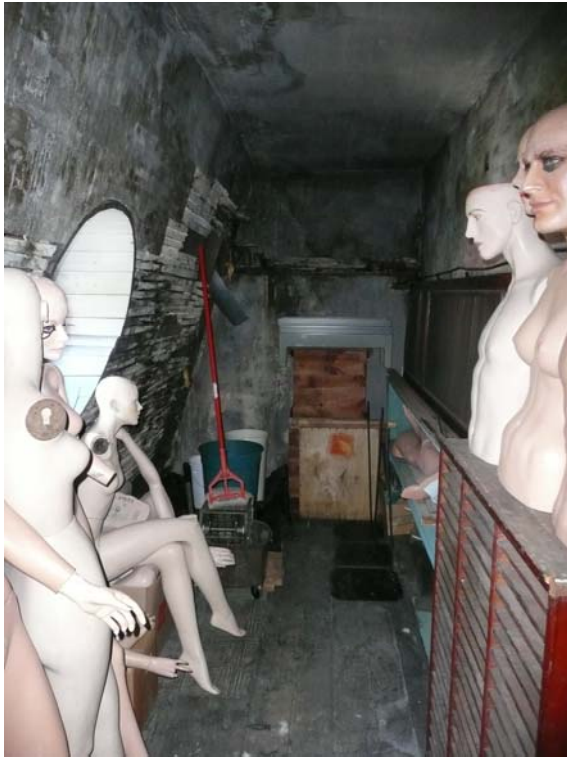
Assessment: Overall fair condition
Repair damaged plaster and paint
Update electrical system

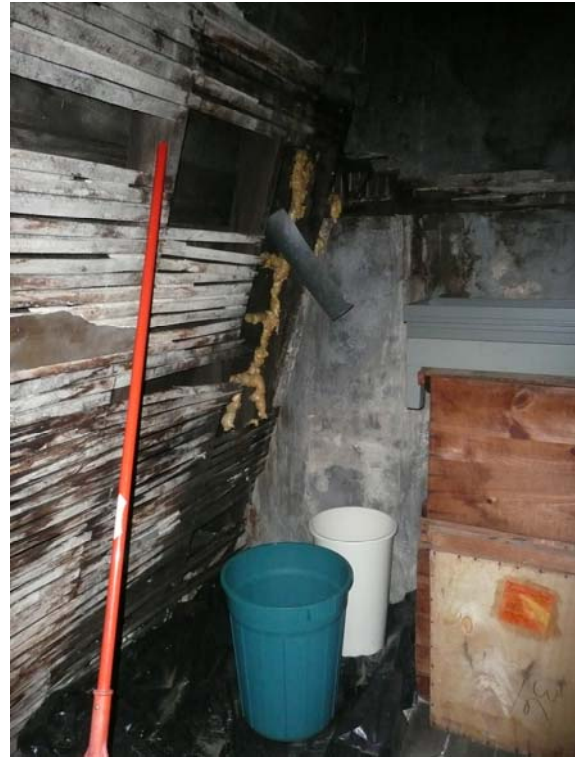
Detail of Southeast Corner with Water Damage

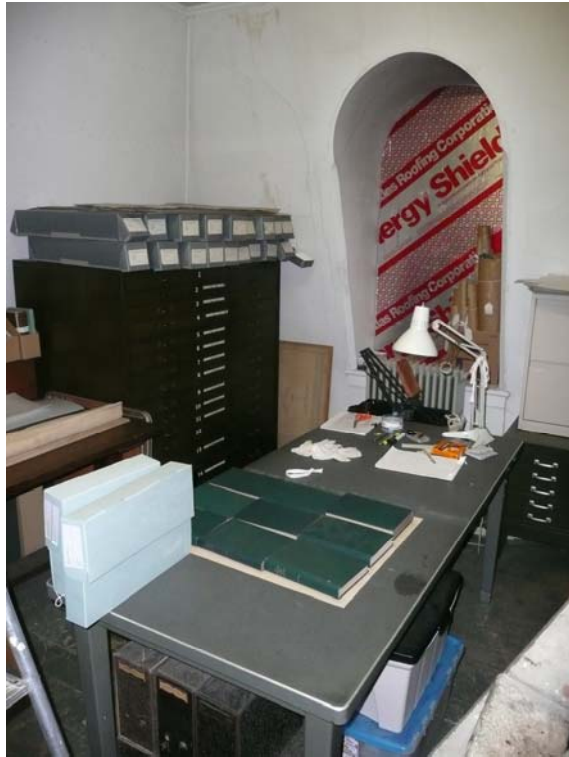
View Looking East at Dormer Window

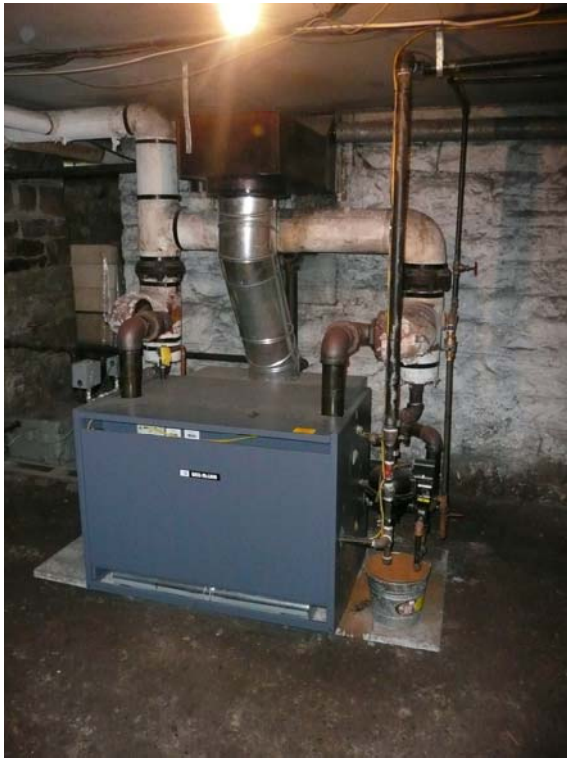
Steam Boiler in Boiler Room B07

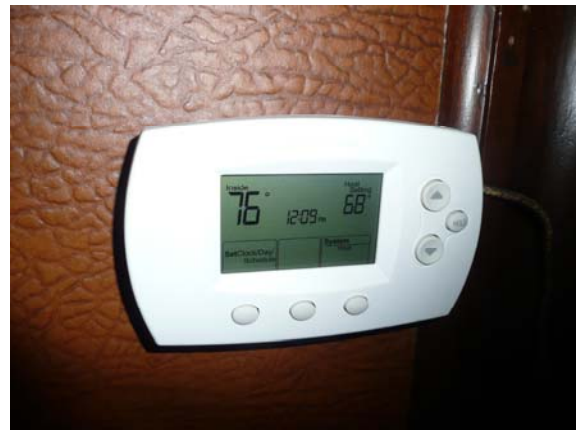
Programmable Thermostat in First Floor Stair Hall

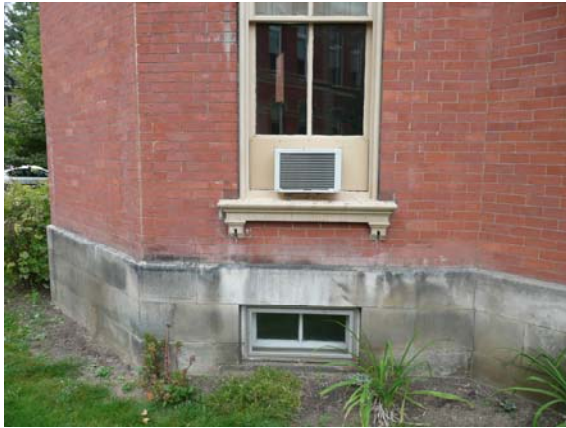
Window AC Unit at Office 102

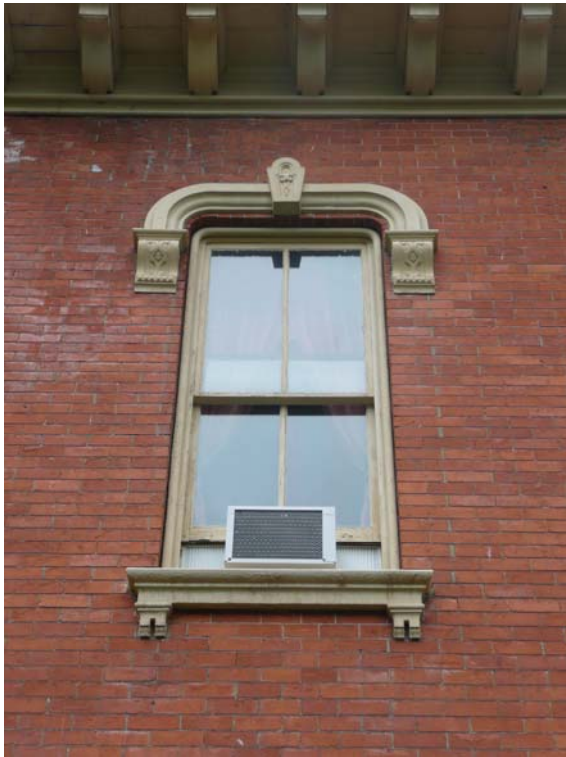
Window AC Unit at Photo Collections 203
