The Struthers-Wetmore-Schimmelfeng House Building Assessment and Preservation Plan

Warren County Historical Society

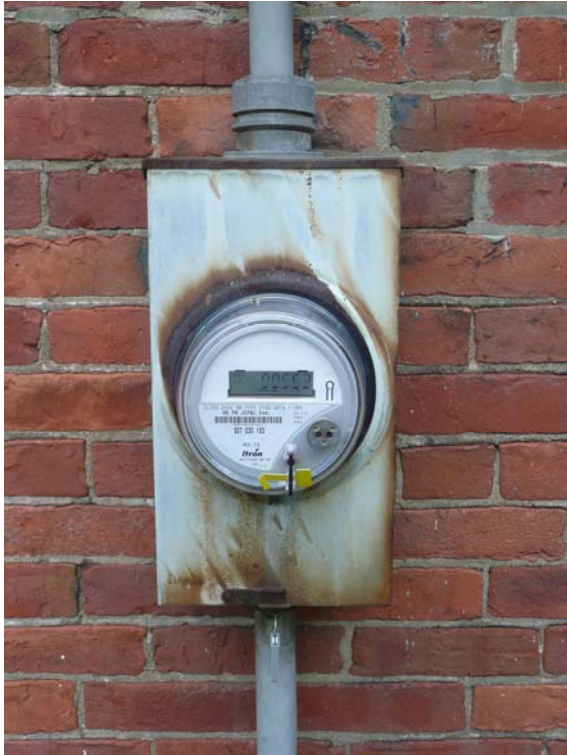
Electric Meter at North Side of Building

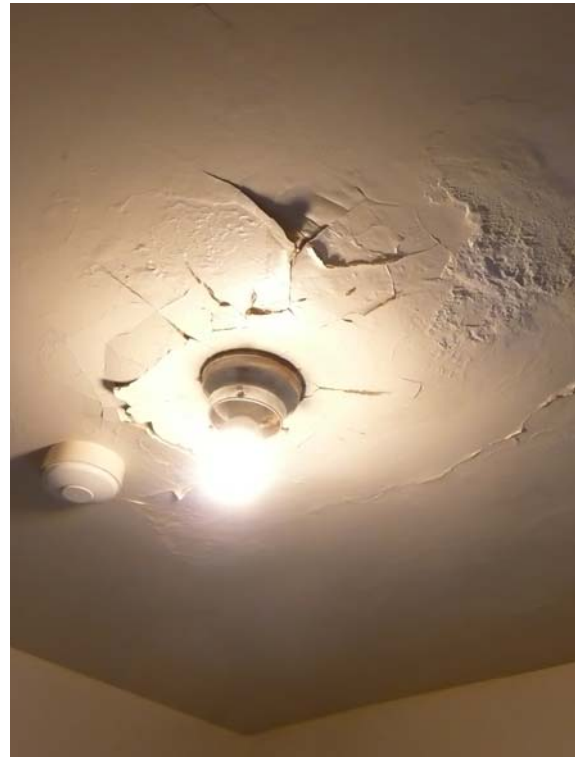
Light Fixture with Plaster Damage at Restroom 211

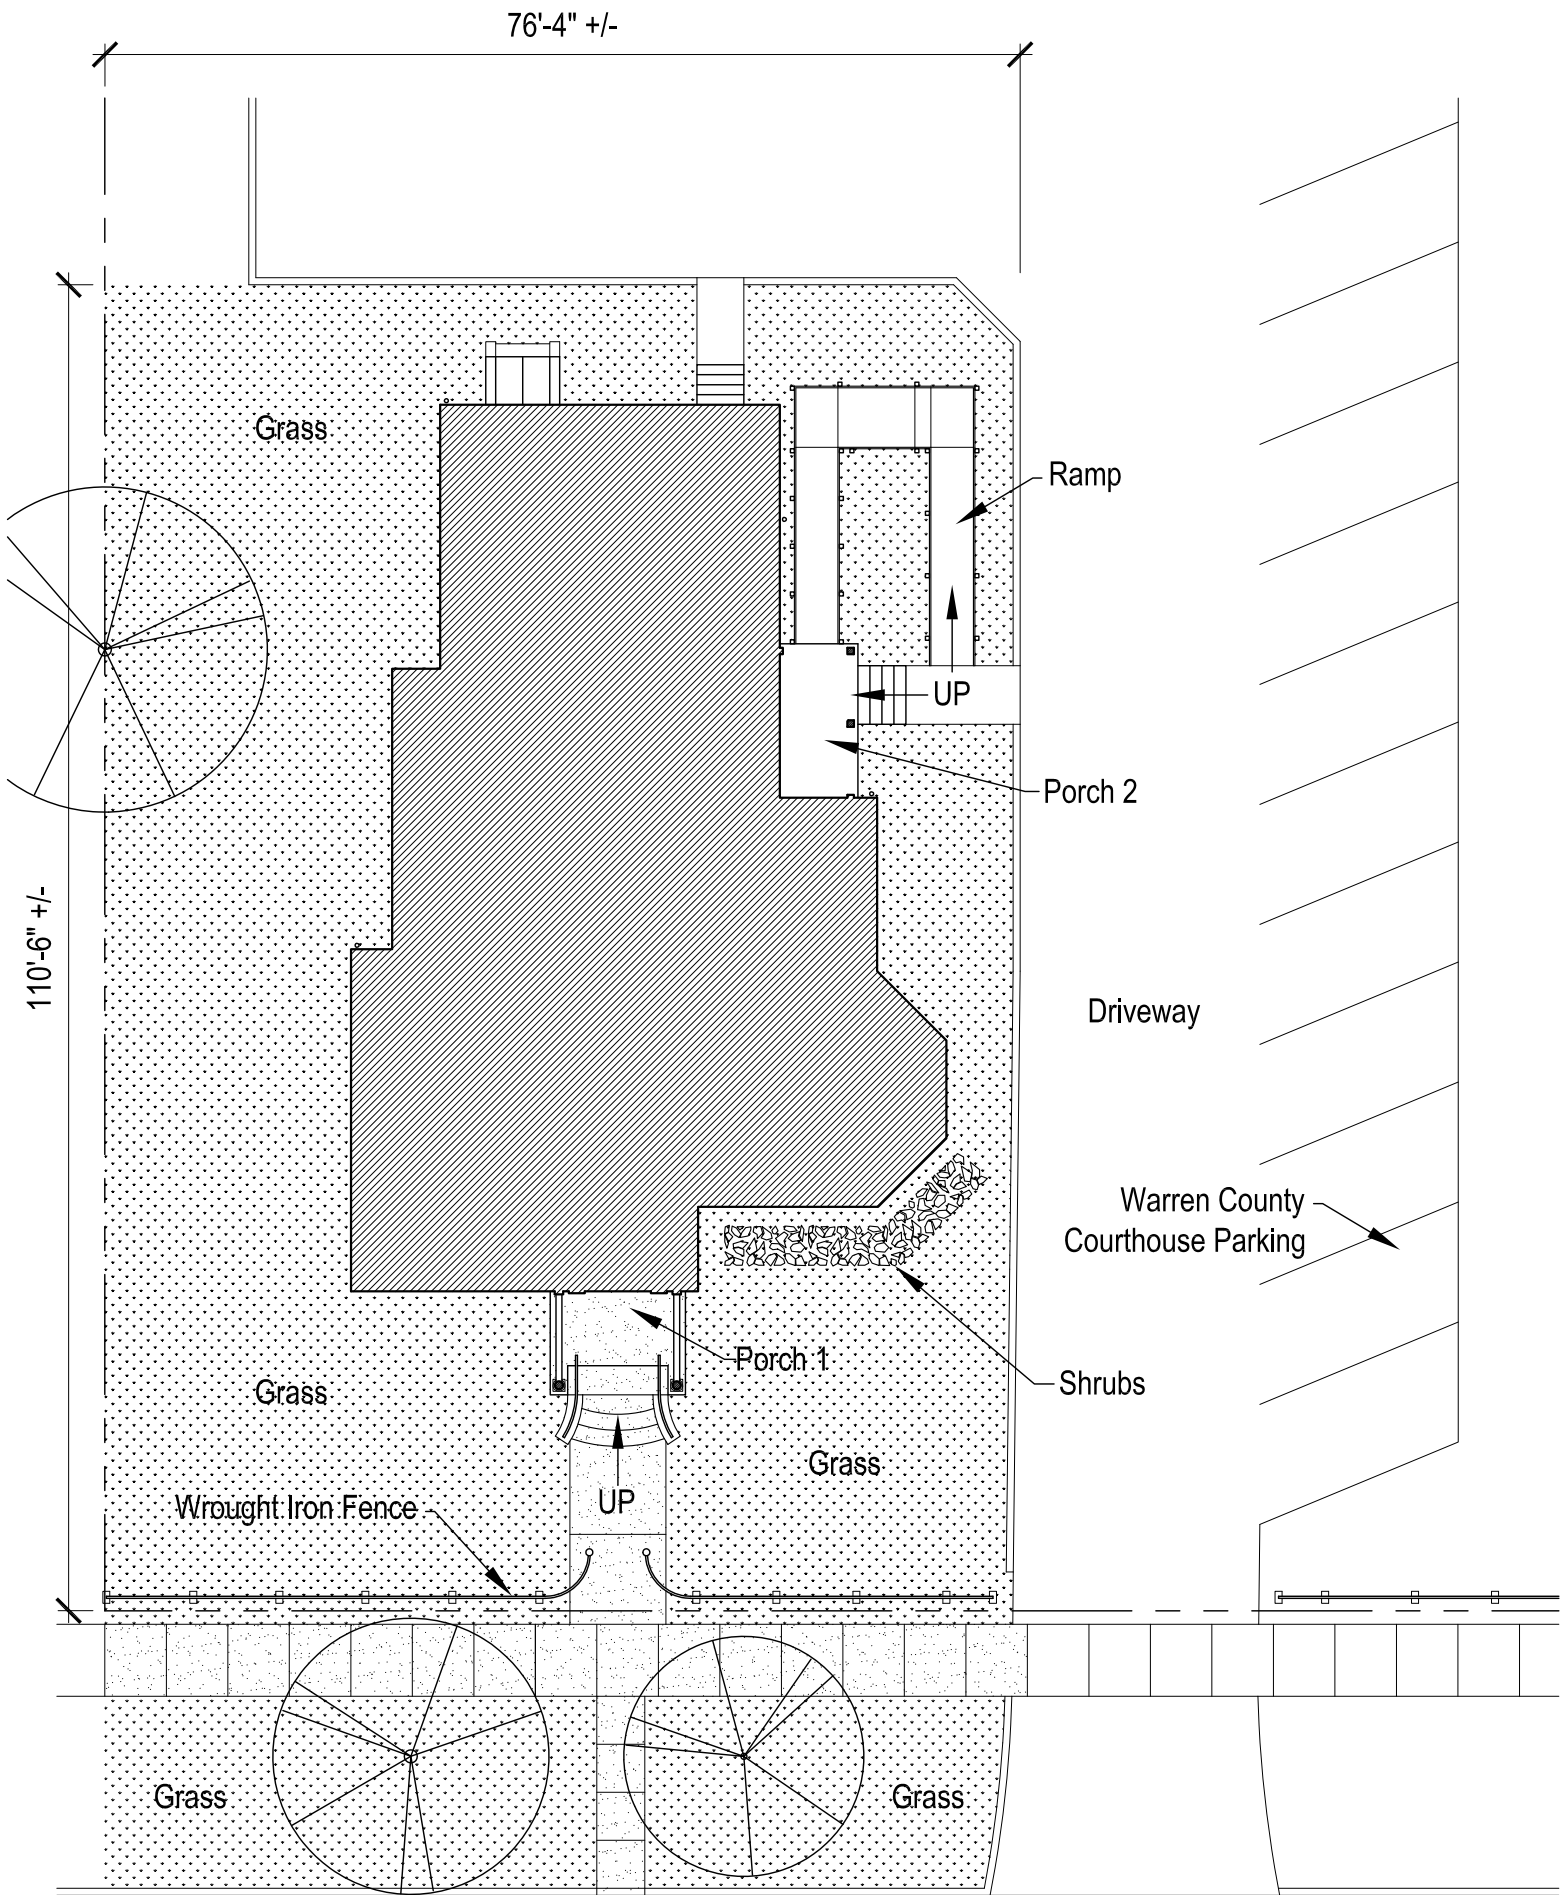
- A. Existing Condition Site Plan and Floor Plans
- B. Existing Condition Photographs (contact sheet format)
- C. National Register Nomination Form
- D. Completion Report for 1979 Exterior Renovations

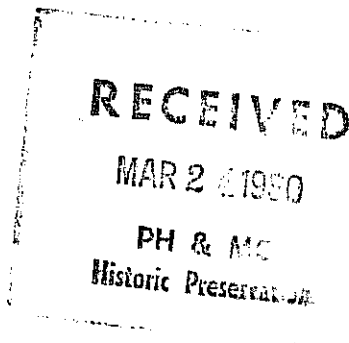
PHOTOGRAPHS - THE WETMORE HOUSE
